Technical Report

An Investigation into the Effect of Near Bottom Currents on the Structural Stability of Enbridge Line 5 in the Straits of Mackinac

Edward E. Timm, PhD, PE
5785 Deer Run Trail
Harbor Springs, MI 49740
231-526-7159 EdTimm@Gmail.com

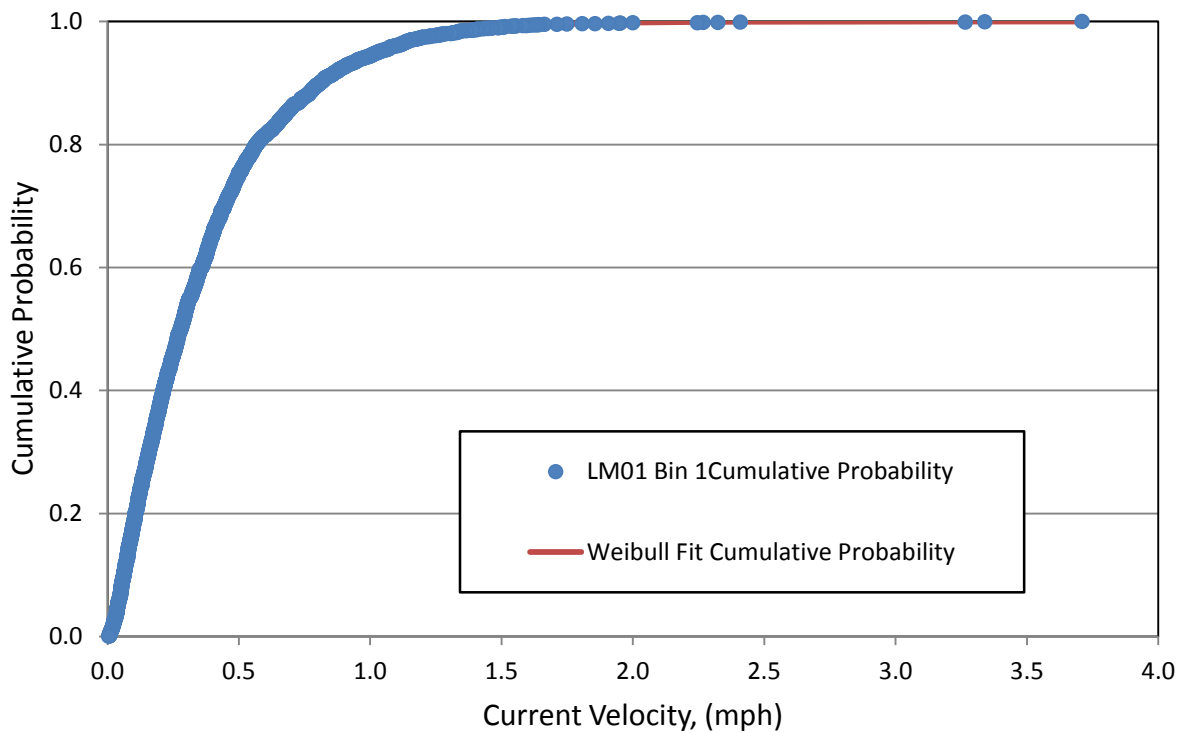
Figure 3. Data and Weibull Fit for the Cumulative Probability Density Function for Buoy LM 01, Bin 1

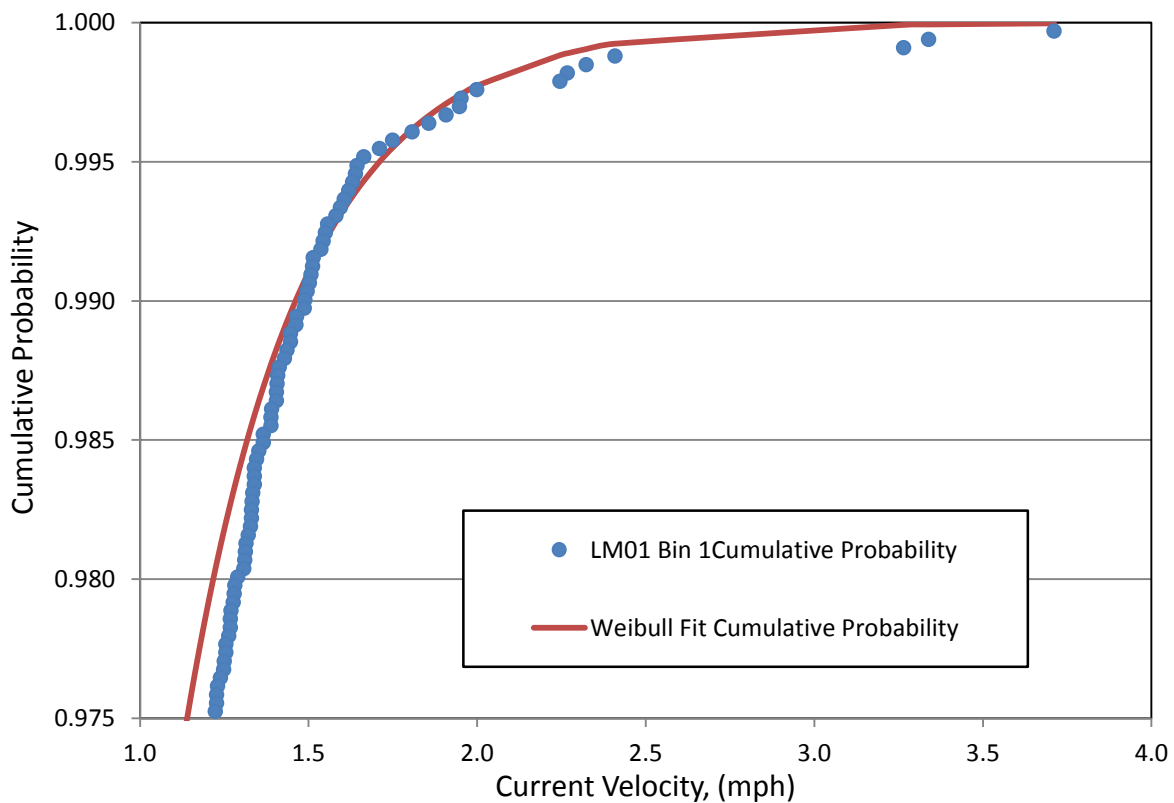
Figure 4. Data and Weibull Fit for the Cumulative Probability Density Function for Buoy LM 01, Bin 1, Upper 1% of Data

The fit parameters for the upper 1% of the LM 01, Bin 1 data can be used to estimate the cumulative probability that the current velocity is greater than a specified value. This increment of probability is called the “tail risk” as it is the total amount of risk that an event with

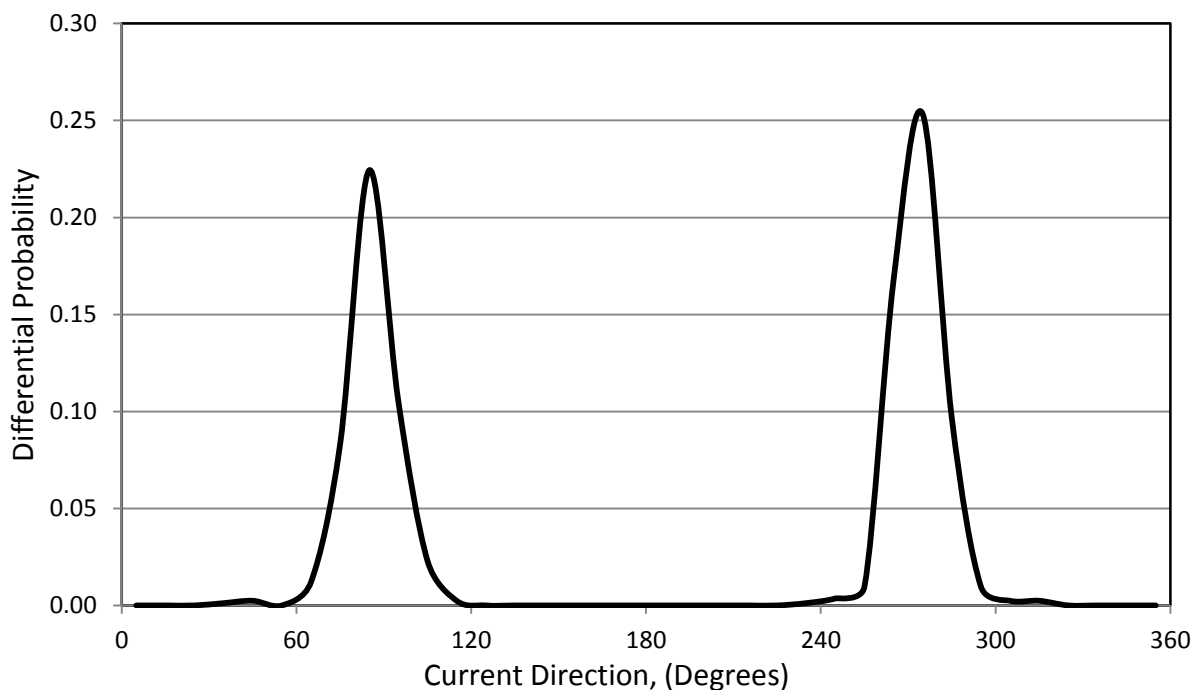
Figure 5. Differential Probability of Current Direction for Upper Quartile of Current Velocities for Buoy Data Set LM 01, Bin 1. (*Current Direction is the direction towards which the flow moves*)

The LM 01, Bin 1 data set was also examined to determine the direction of current flow. The upper 25% of current velocity data was used to calculate the differential probability density of current direction. This data was sorted into bins of 10° width resulting in the differential probability distribution for current direction shown in Figure 5.

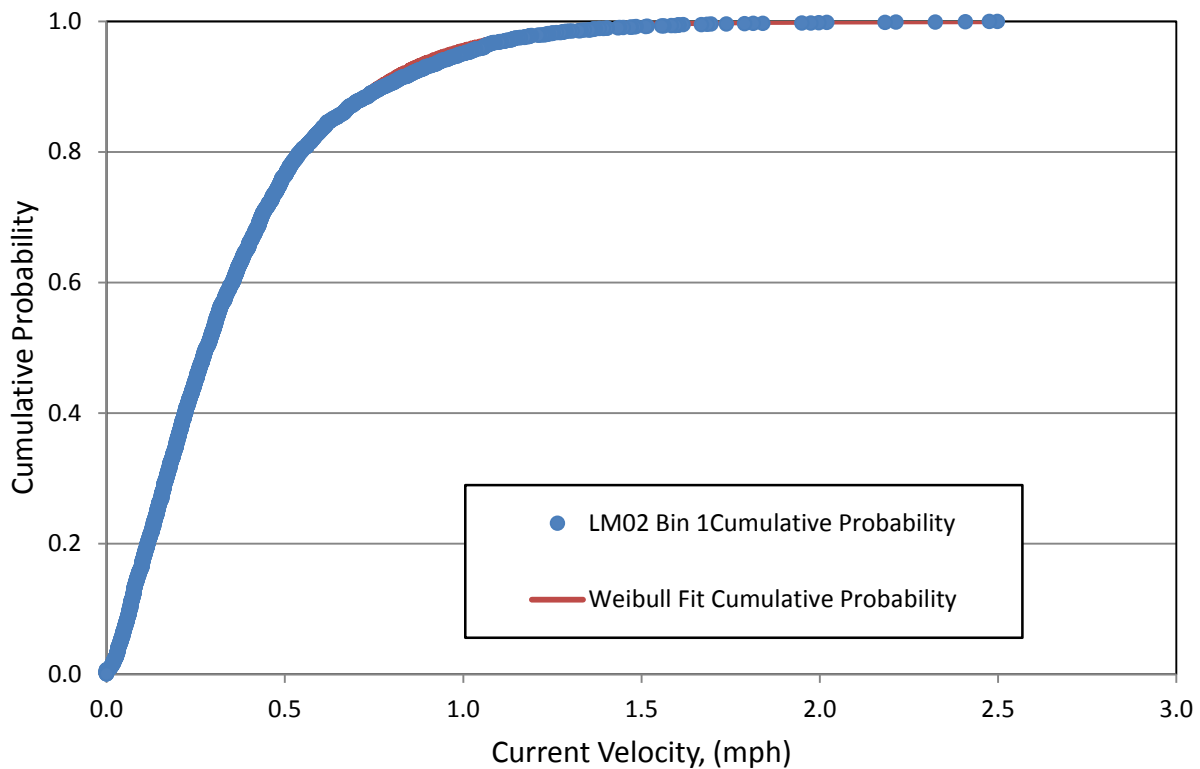
Figure 6. Data and Weibull Fit for the Cumulative Probability Density Function for Buoy LM 02, Bin 1

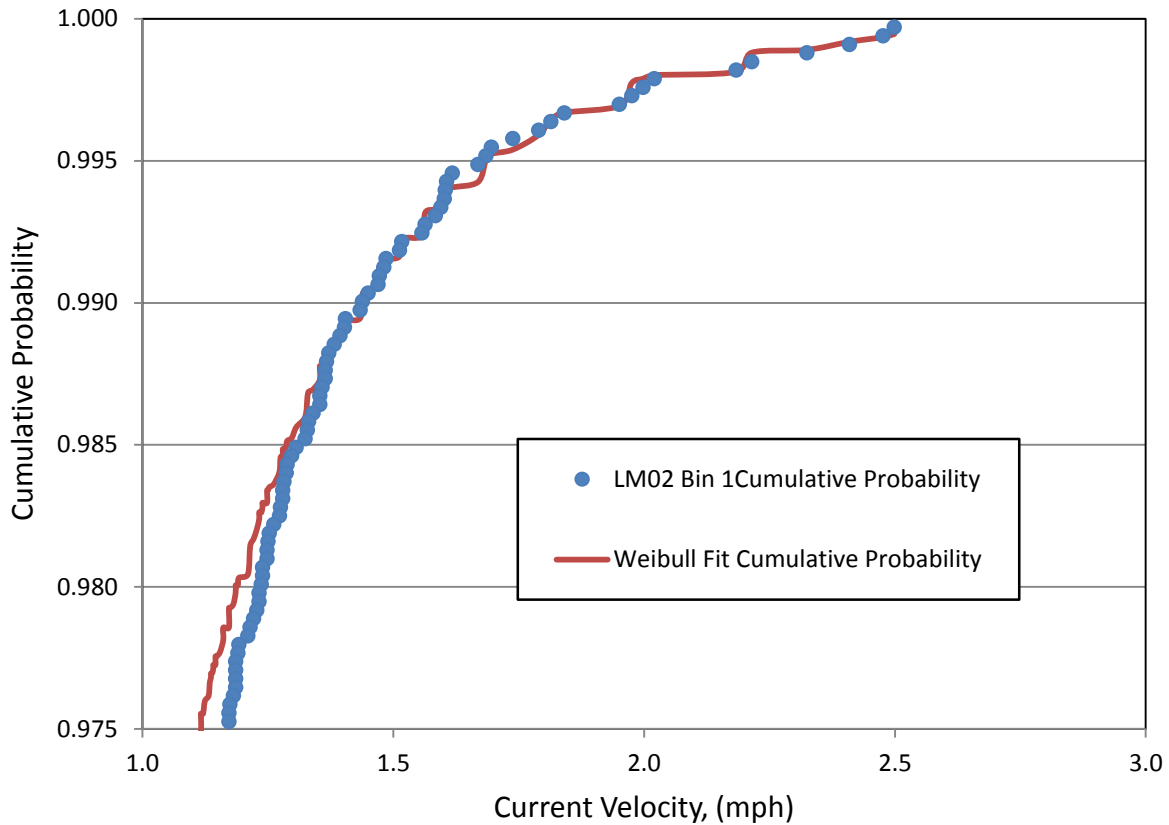
Figure 7. Data and Weibull Fit for the Cumulative Probability Density Function for Buoy LM 02, Bin 1, Upper 1% of Data

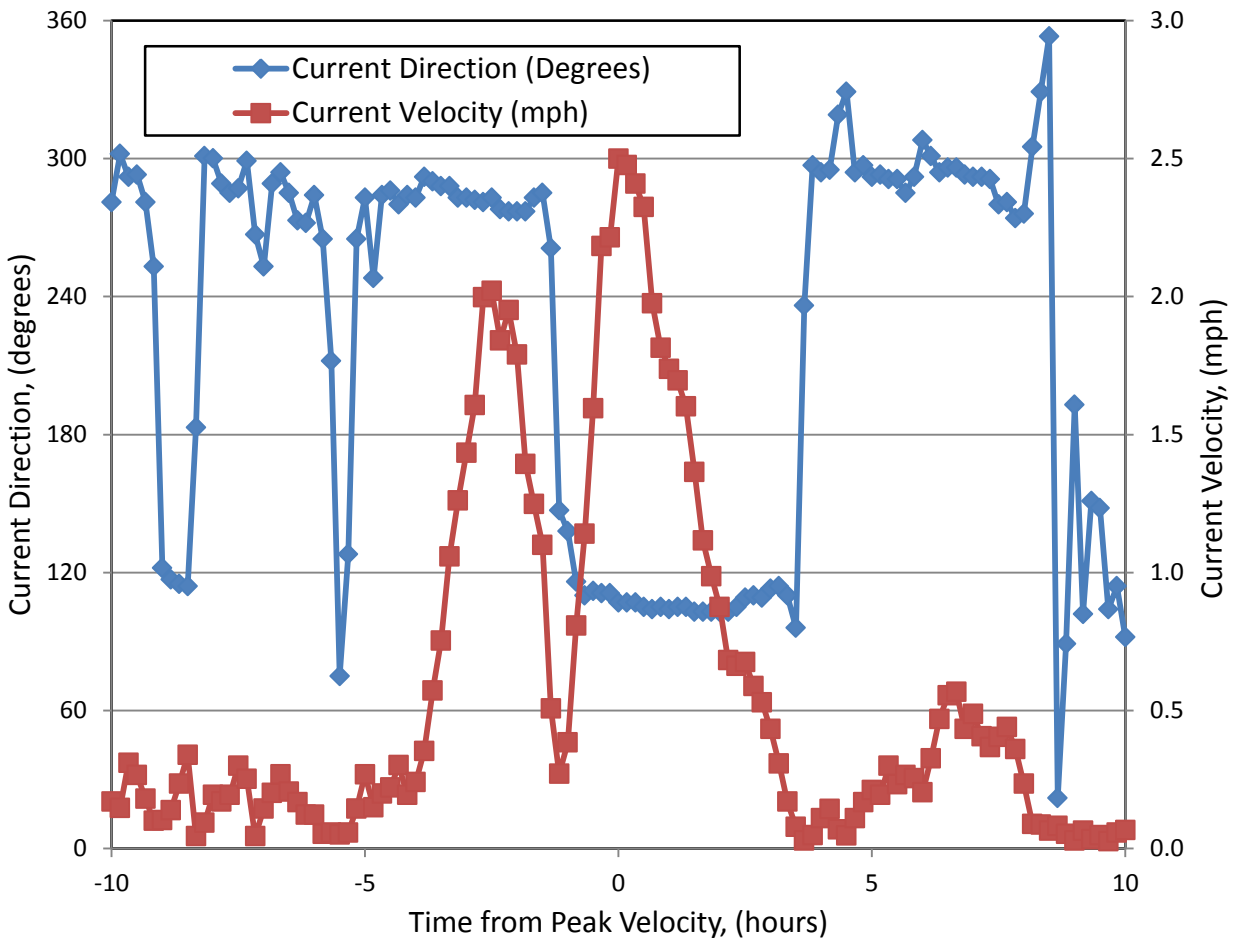
Figure 9. Current Velocity and Direction during a Peak Velocity Event for Buoy Data Set LM 02, Bin 1

None of the above considerations serve address how the flow around Line 5 can vary in a short period of time. Figure 9 displays current velocity and direction during the ten hours

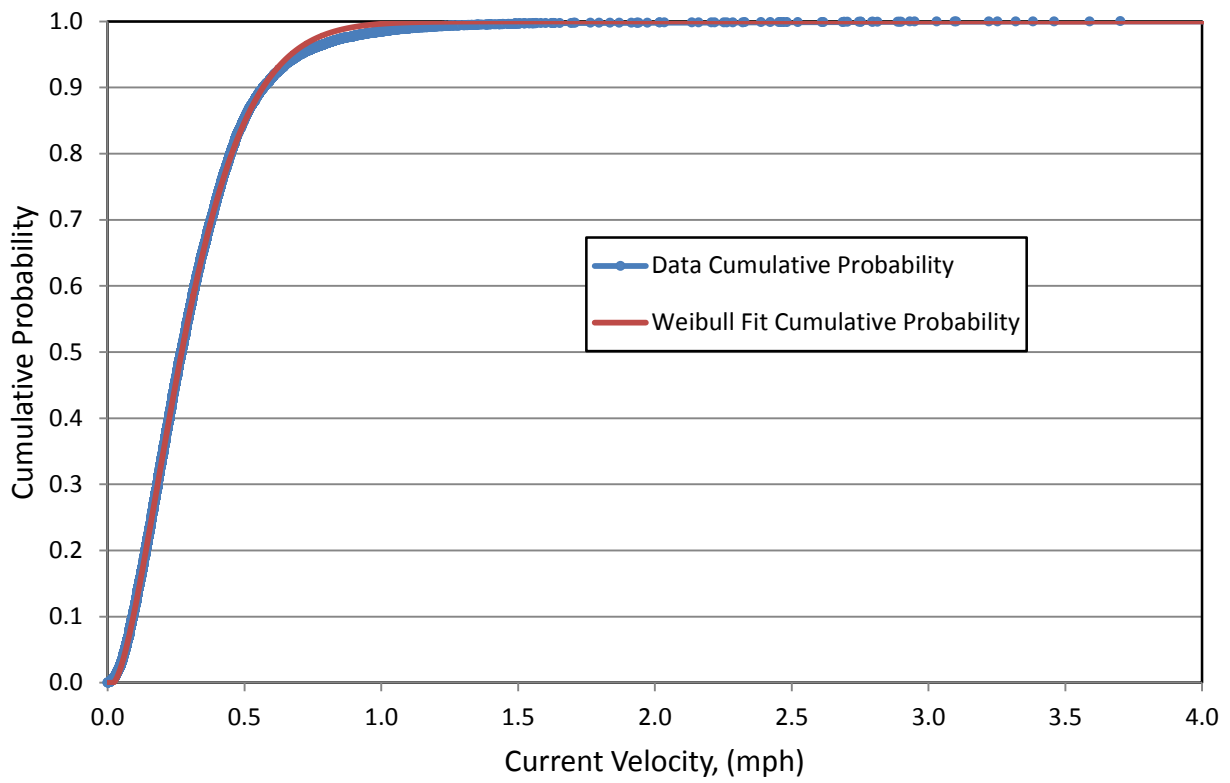
Figure 10. Data and Weibull Fit for the Cumulative Probability Density Function for Buoy 45175, Bin 27

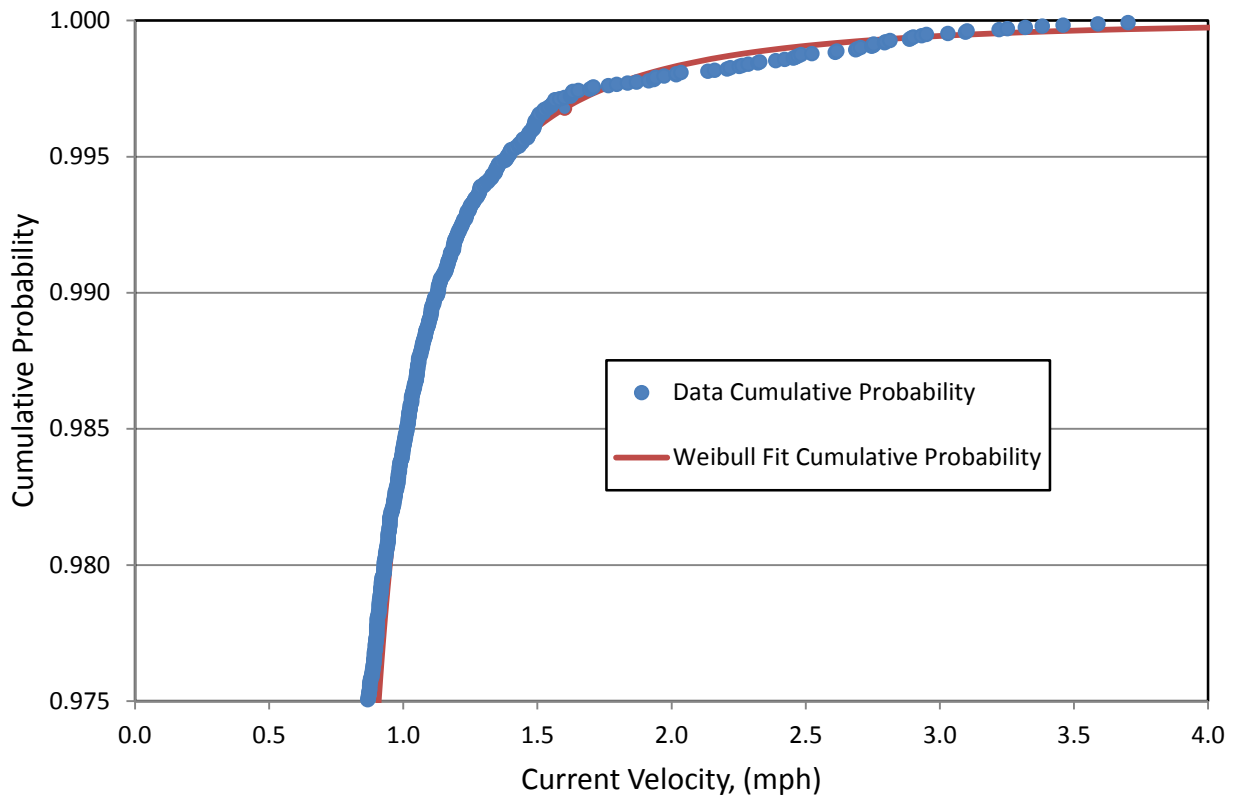
Figure 11. Data and Weibull Fit for the Cumulative Probability Density Function for Buoy 45175, Bin 27, Upper 1% of Data

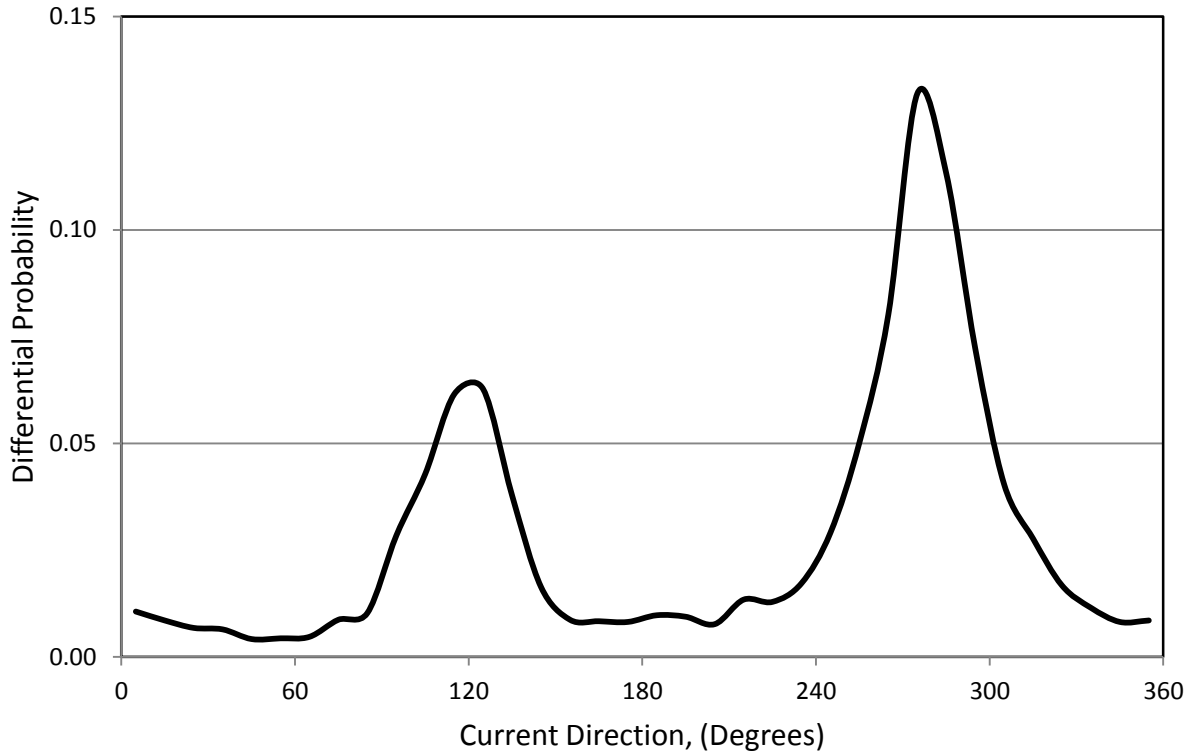
Figure 12. Differential Probability of Current Direction for Upper Quartile of Current Velocities for Buoy Data Set 45175, Bin 27

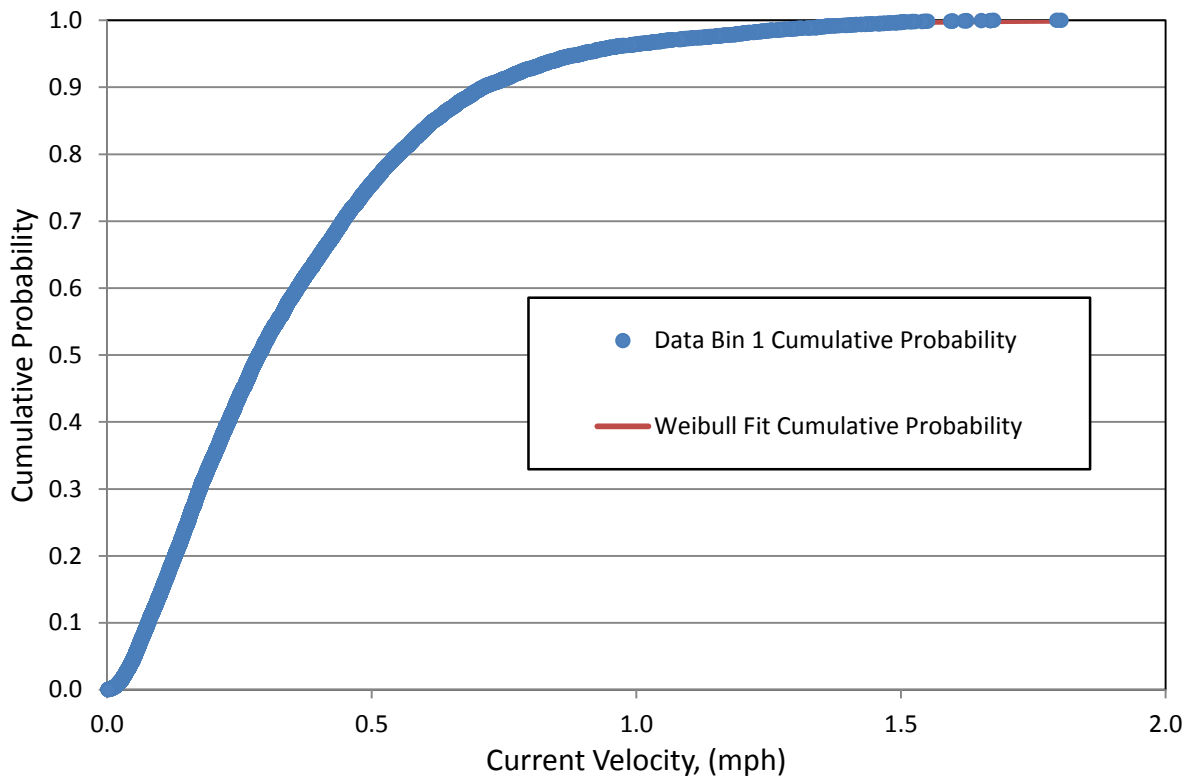
Figure 13. Data and Weibull Fit for the Cumulative Probability Density Function for Buoy wh3748_2014_1S, Bin 1

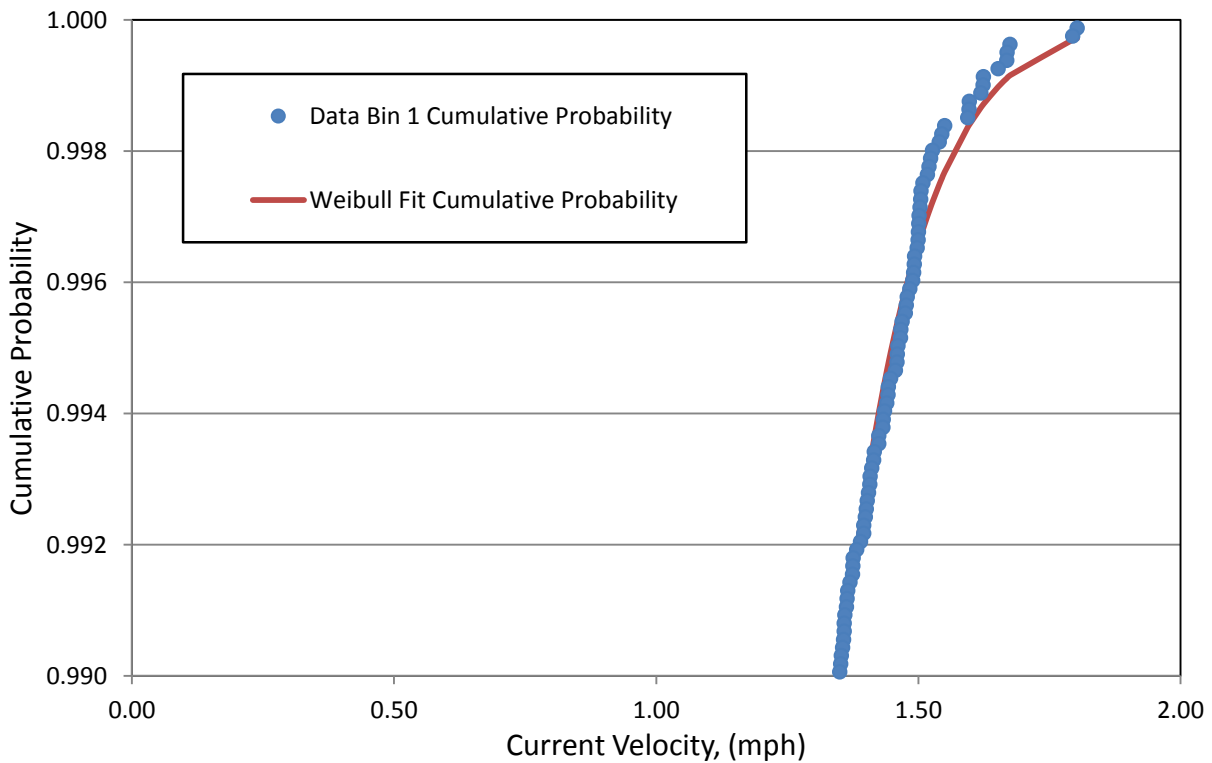
Figure 14. Data and Weibull Fit for the Cumulative Probability Density Function for Buoy wh3748_2014_1S, Bin 1, Upper 1% of Data

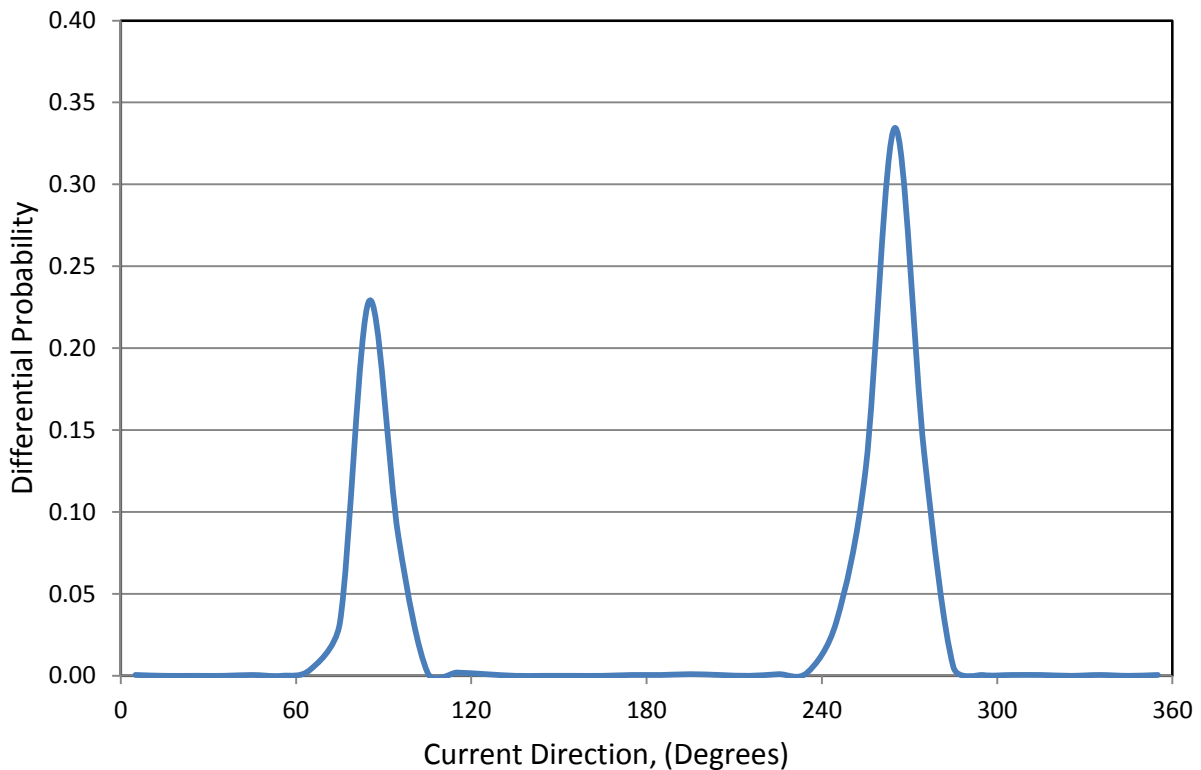
Figure 15. Differential Probability of Current Direction for Upper Quartile of Current Velocities for Buoy Data Set wh3748_2014_1S, Bin 1

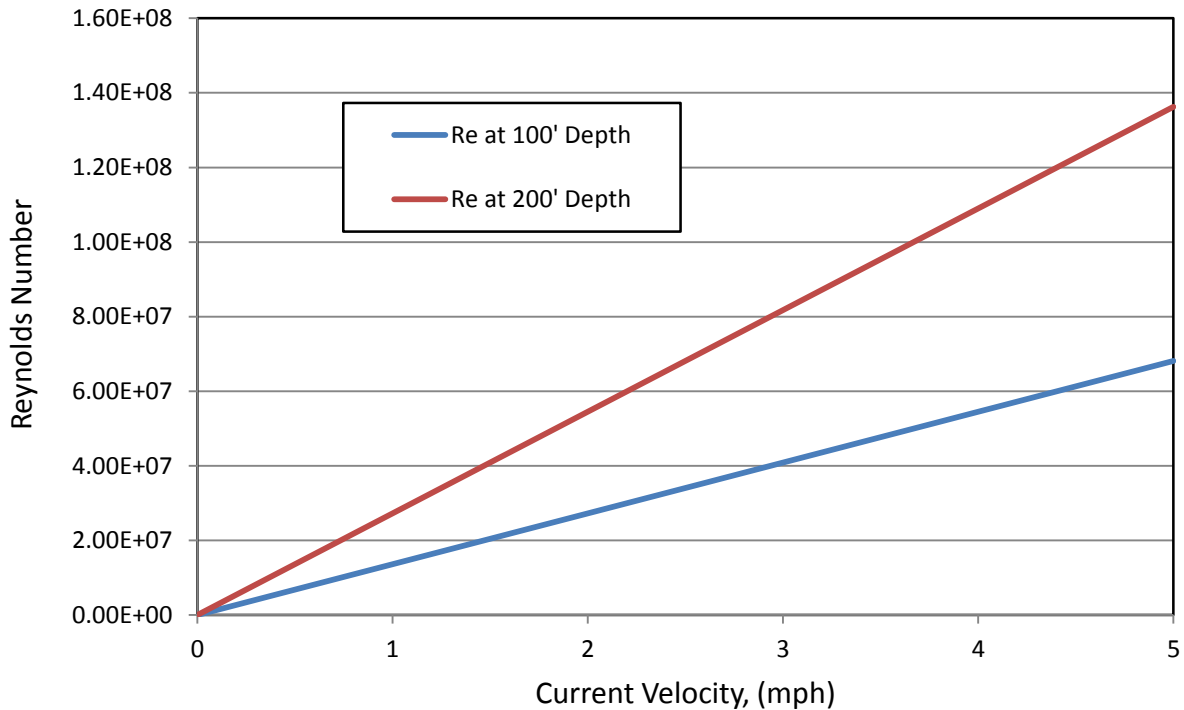
Figure 16. Reynolds Number for Flow in an Open Channel at 20° Centigrade

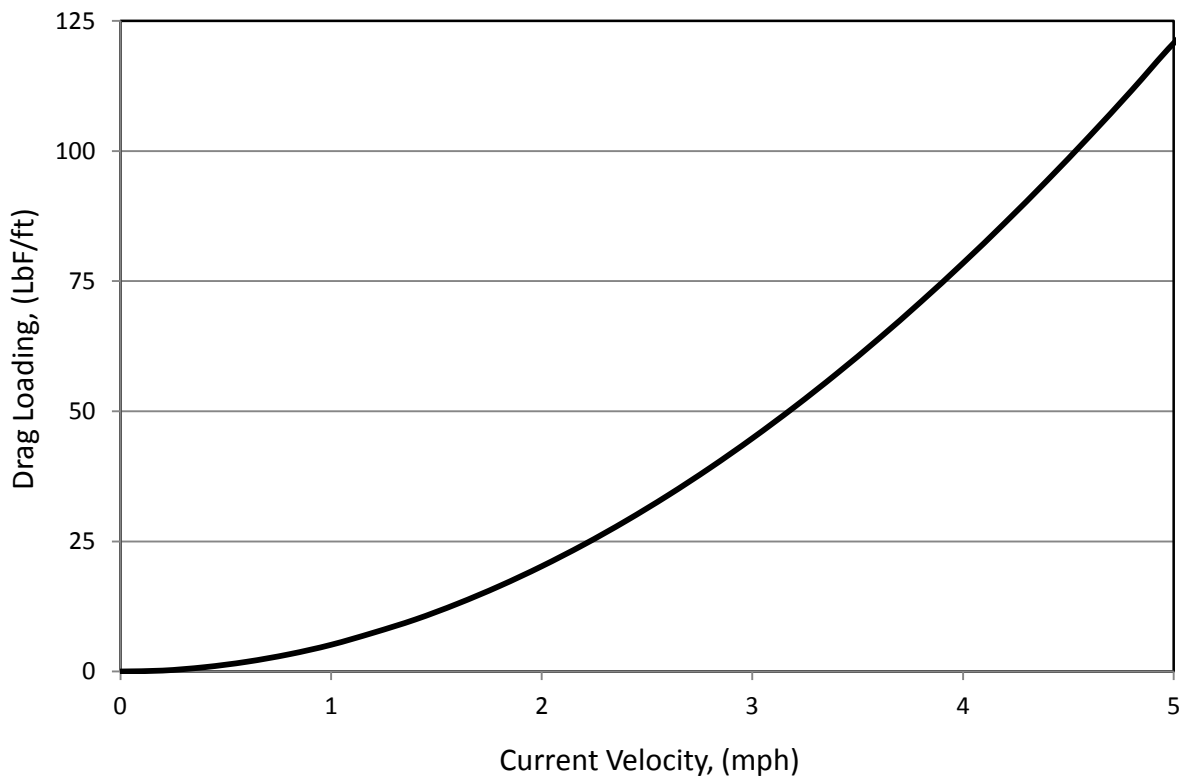
Figure 18. Drag Force on a Circular Cylinder with a 22 inch Diameter and a Surface Roughness of 30×10^{-3} at 10^0 C Water Temperature

Drag coefficients determined from Figure 17 were based on a pipe diameter of 22 inches and a surface roughness of 30×10^{-3} which reflects a very rough pipe that is fouled with biota and sediment. The Reynolds numbers calculated for velocities in the range of interest range from 10^5 to 10^6 , a range where the Cd's determined from Figure 17 are reliable.

Figure 17 applies to a cylinder in a free stream. Line 5 exists in a condition where it may be resting on the bottom or where an unsupported span may be many pipe diameters from the bottom. When the pipe is resting on the bottom, the flow around the pipe is stagnated and the drag force on the pipe results in a rolling moment on the pipe which induces a resisting torque. This situation was analyzed by Salvadori for velocities up to 2.25 mph and was found not problematic. Once the pipe is off the bottom, flow around the pipe results in a bending moment which must be considered together with the forces from internal pressure and gravity. Yang, Jeng, Gao and Wu¹⁹ have analyzed the scenario where the pipe is supported at various distances from the lake bottom and found that if the pipe is further than about 80% of the pipe diameter from the bottom it acts as if it is in a free stream. The drag force values in Figure 18 are valid as long as this condition is met. When the pipe is closer to the lake bottom than 80% of the pipe diameter, the situation becomes complex and the drag forces may be either greater or lesser than those computed for Figure 18.

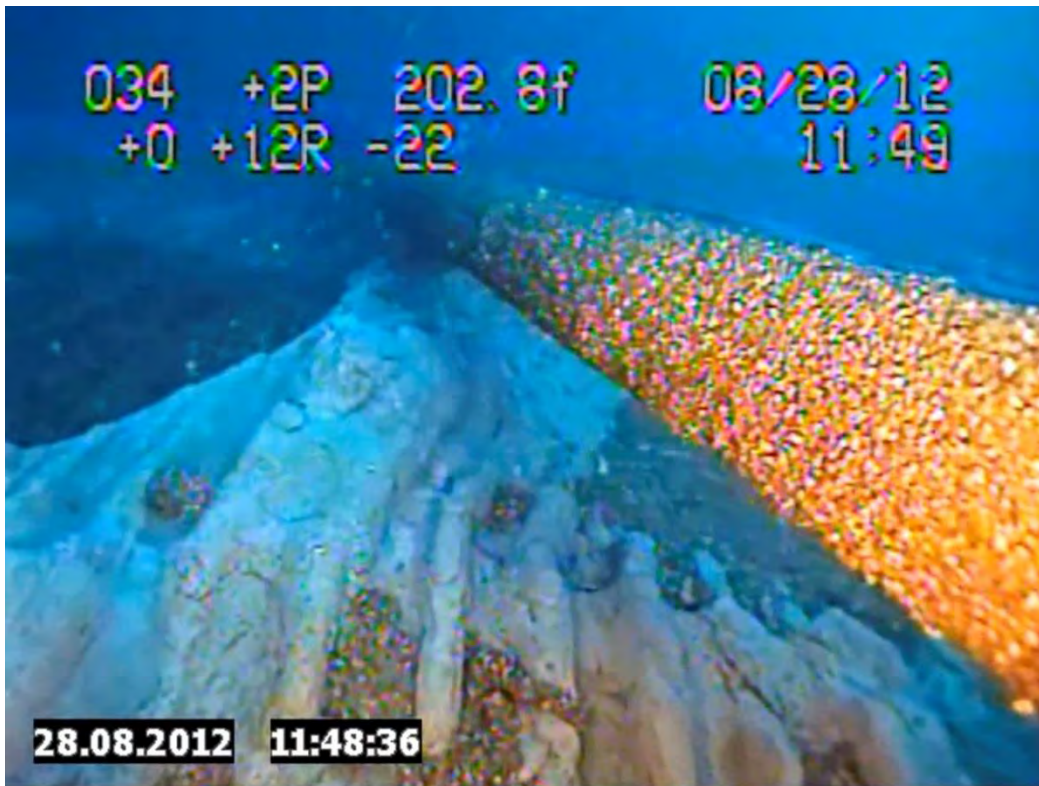
Figure 19. Photo of Unsupported Span Clipped from Enbridge Underwater Inspection Video from the 2012 Inspection (East Leg, ~203 feet water depth)

Enbridge Line 5 mostly rests on the lake bottom. However, as explained in Appendix 1, several unsupported spans were left from the original construction or developed later due to bottom scouring or “washout”. Figure 19 is a photograph taken from Enbridge’s 2012 underwater inspection video that illustrates an unsupported span on the east leg near the south side of the ancient river bed that runs through the Straits. Although it is hard to exactly determine the distance from the pipe to the lake bottom it appears to be on the order of ten to fifteen feet. It also appears in this photo that the bottom is scoured clean of sediment since the marks left in the hardpan clay bottom by the teeth of the clamshell dredge used to level this area during construction in 1953 are still prominent.

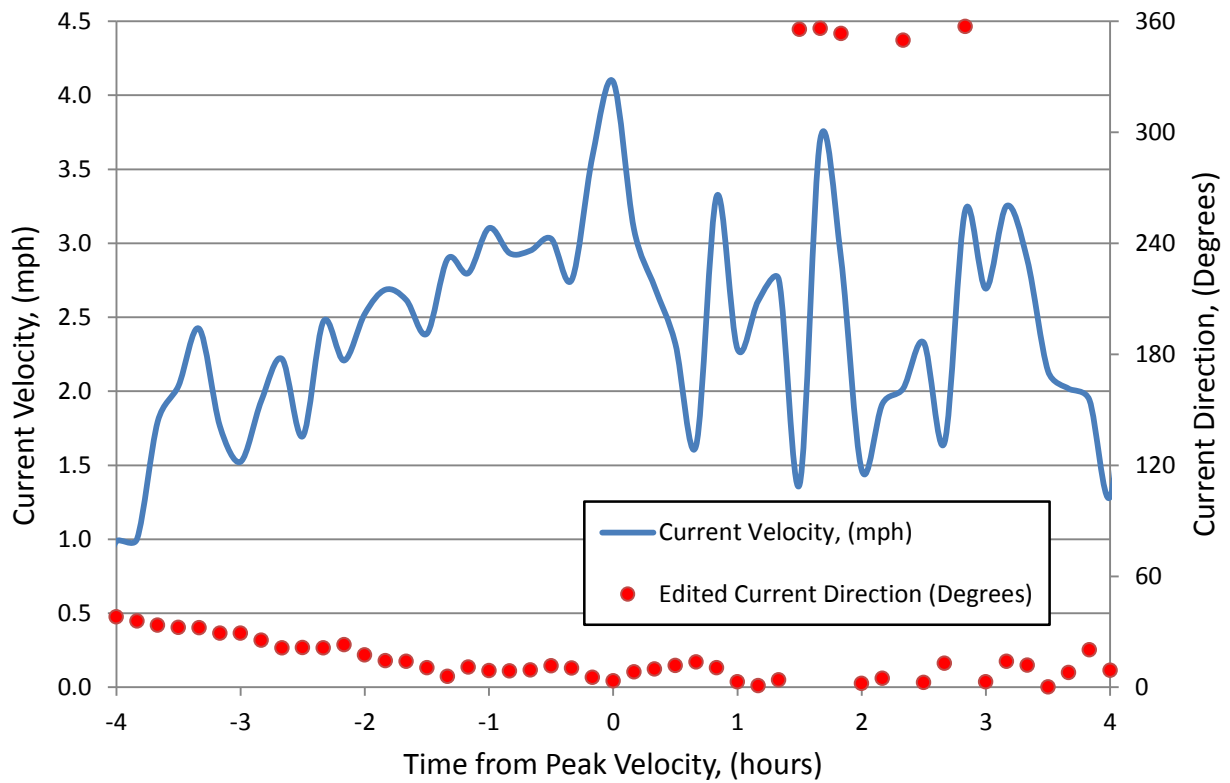
Figure 21. Correlation of Current Velocity and Current Direction During a Peak Current Event for Buoy Data Set 45175

Table 13 shows the amount of time that the current velocity is estimated to be greater than 3.6 mph, the condition where a 160 foot unsupported span will reach the yield stress of X35 steel. Reference to Figure 21 shows that peak current events of significant magnitude typically last for about 20-30 minutes. Using the value of 30 minutes per peak current event results in the number of possible fatigue cycles due to bulk flow during extreme current events at three buoy locations for a 160 foot unsupported span. Based on this assumption, it is likely that the 160' unsupported span located at Bechtel Station 11800 has been subjected to between 200 and 300 reversing bending cycles over the 48 year period it was out of compliance with easement conditions and Salvadori's calculations.

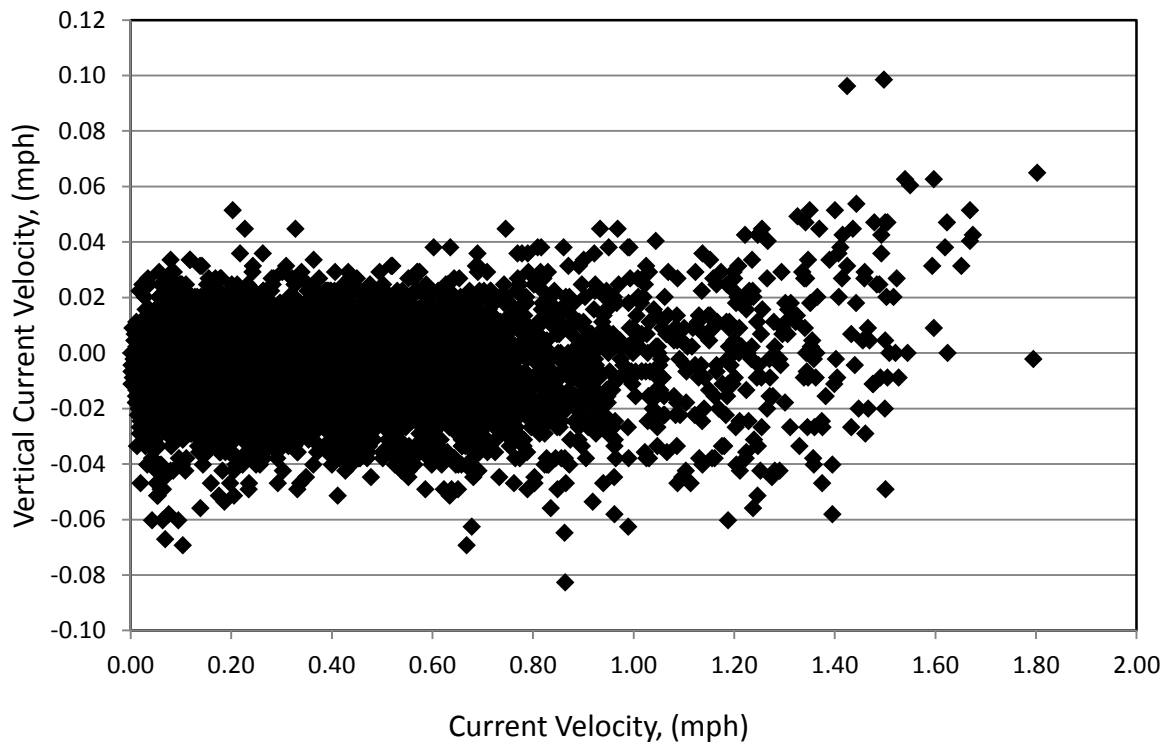
Figure 22. Scatter Plot Correlating Planar Current Velocity with Vertical Current Velocity for Buoy wh3748_2014_1S, Bin 1

ADCP units are also capable of measuring z axis or vertical flows. Figure 22 is a scatter plot of vertical current velocity as a function of planar current velocity for the entirety of bin 1 data from buoy wh3748_2014_1S. The very low vertical current velocities measured at this location are at the limit of resolution for ADCP technology and generally do not show a significant correlation of vertical current velocity with planar current velocity.

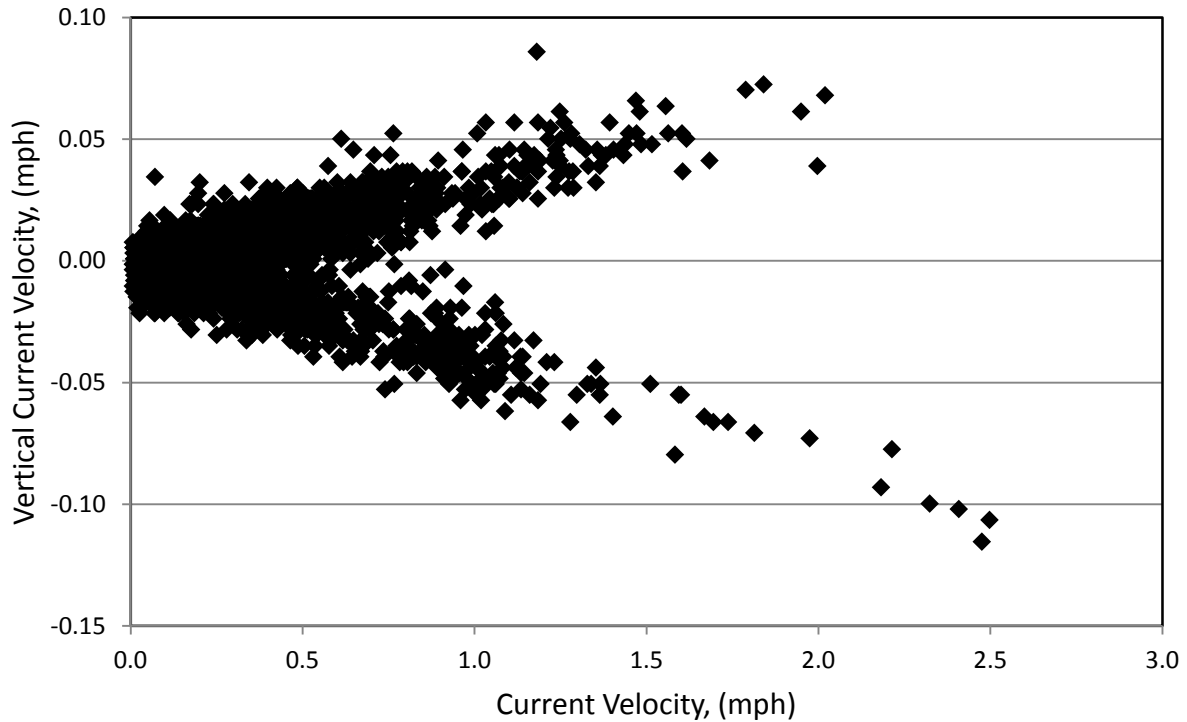
Figure 23. Scatter Plot Correlating Planar Current Velocity with Vertical Current Velocity for Buoy LM 02, Bin 1

Figure 23 is a scatter plot of vertical current velocity as a function of planar current velocity for the entirety of bin 1 data from buoy 45175. This plot shows a bifurcated correlation between vertical current velocity and the planer current velocity in this location. Although this vertical current velocity data is also at the limit of ADCP resolution, the correlation is significant because of the thousands of data points represented.

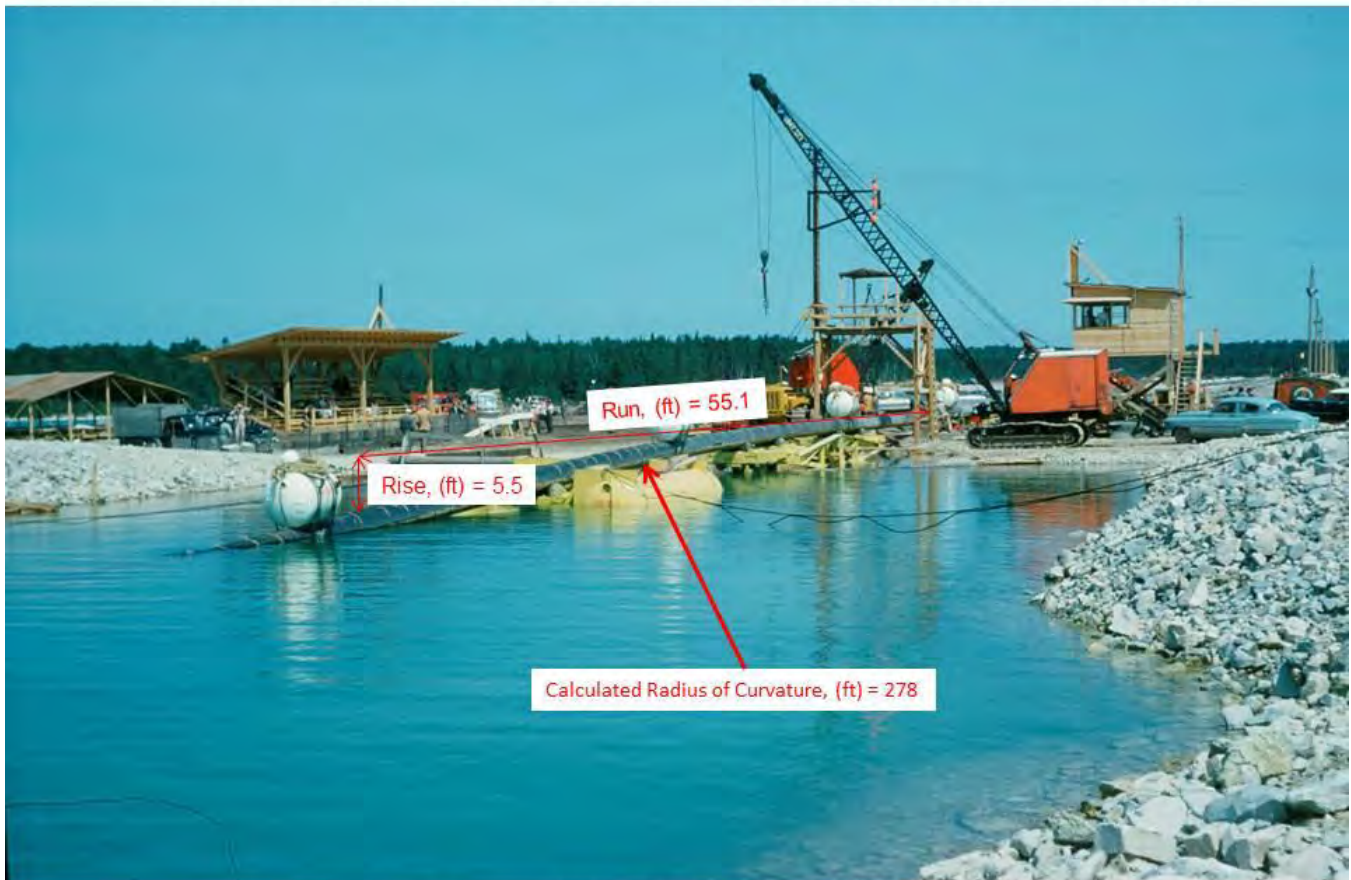
Figure 28. Estimation of Radius of Curvature During the Pipe Laying Operation in 1953 Figure 28. Estimation of Radius of Curvature During the Pipe Laying Operation in 1953

2. One specification set forth in the easement was that “The minimum curvature of any section of pipe shall be no less than two thousand and fifty (2,050) foot radius.” This specification was stricter than the one recommended by Salvadori in his engineering analysis where he recommended a minimum radius of curvature of 1750 feet. Calculation shows that the outer fiber of the pipe will reach yield at a radius of 690 feet. Both of these specifications were intended to prevent the welded pipe strings from being bent to a radius that would cause yielding and the accumulation of fatigue cycles during the pipe laying process. Figure 28 uses a photograph taken by Bruce Trudgen in 1953 that shows the pipe being pulled from the St. Ignace shoreline during the launching process. By carefully scaling the photo, it is clear that the pipe was yielded during launch by bending to a radius of curvature of ~300 feet. More importantly, as Trudgen mentions in his Spartan Engineer²³ article, the 2500 foot welded pipe

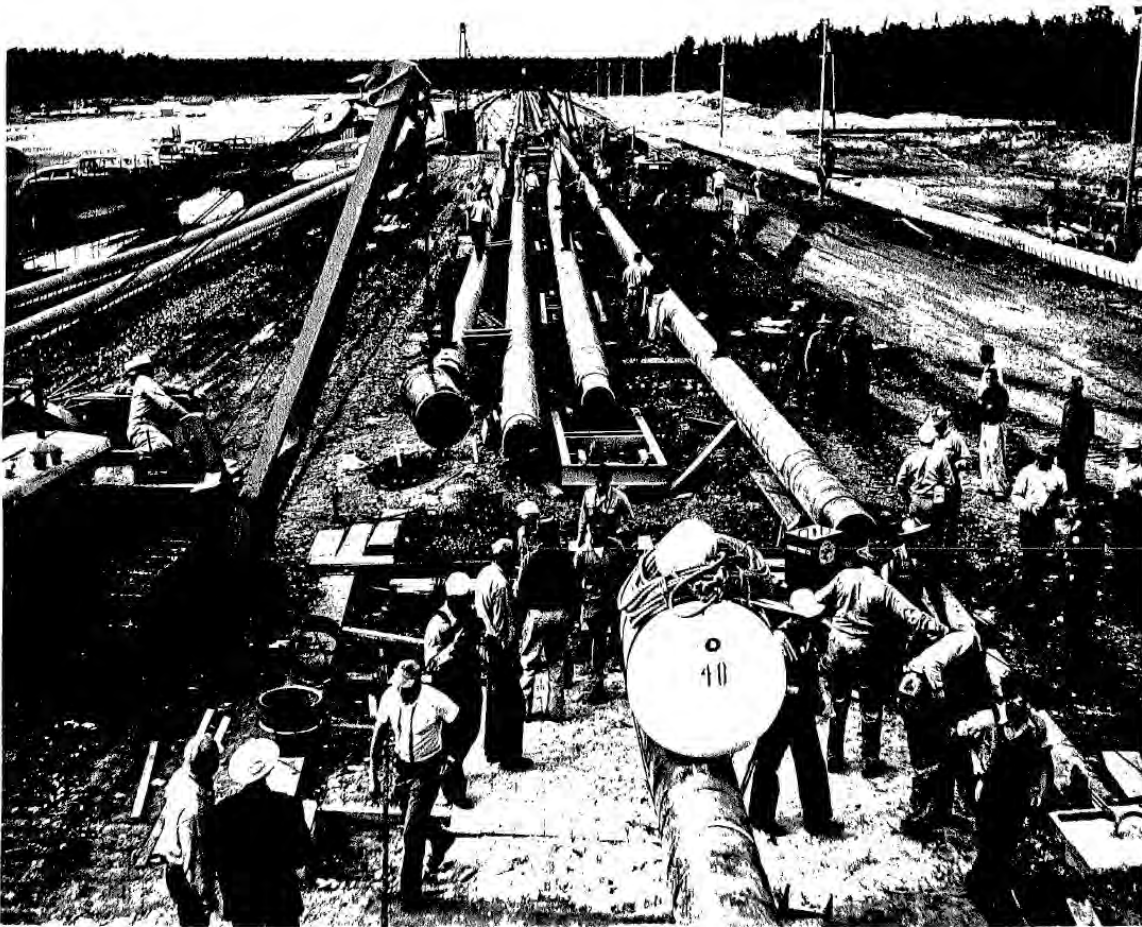
Figure 29. 1953 Photograph Showing Curvature of Pipe String as it is Moved onto the Launch Way Using a Crane

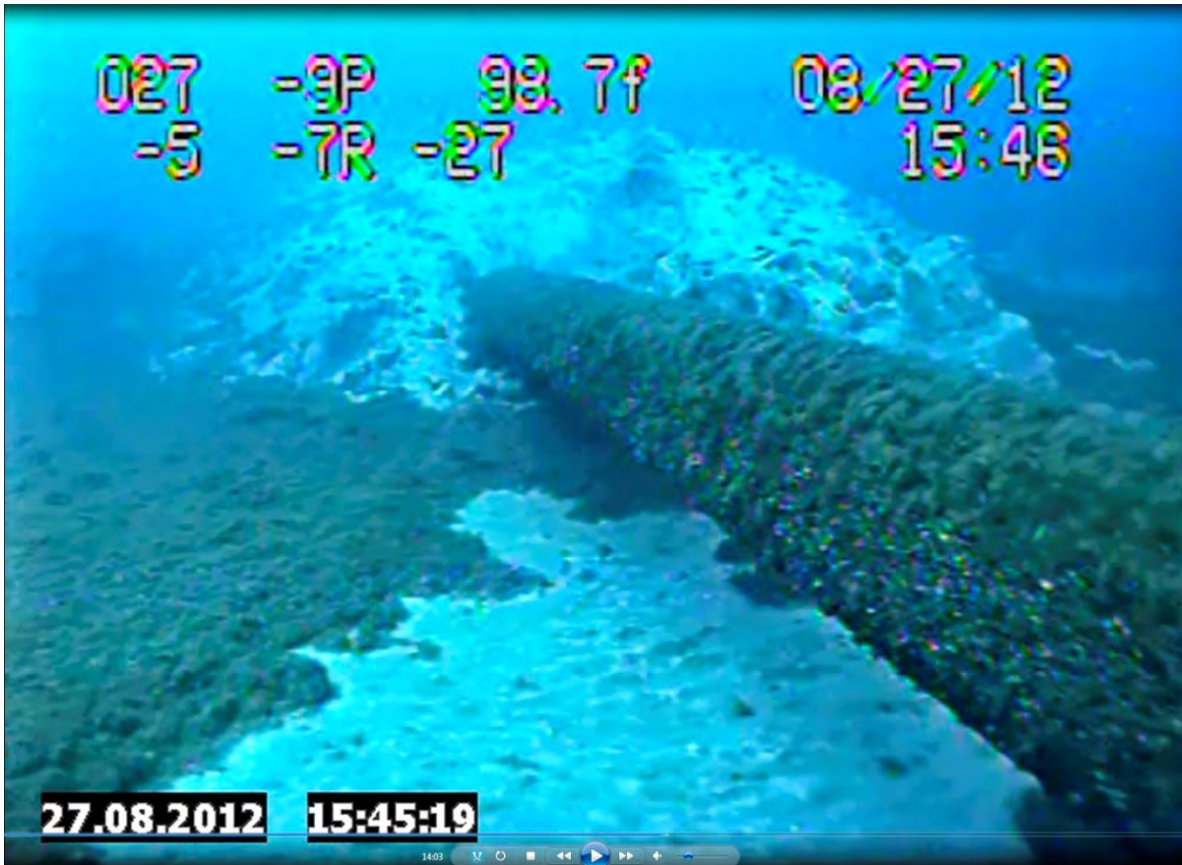
Figure 30. Frame Grab from Enbridge 2012 Underwater Inspection Video²⁴ of the East Leg of Line 5 under the Straits of Mackinac Depicting a Clay Pile
