Technical Report

An Investigation into the Effect of Near Bottom Currents on the Structural Stability of Enbridge Line 5 in the Straits of Mackinac

Edward E. Timm, PhD, PE
5785 Deer Run Trail
Harbor Springs, MI 49740
231-526-7159 EdTimm@Gmail.com

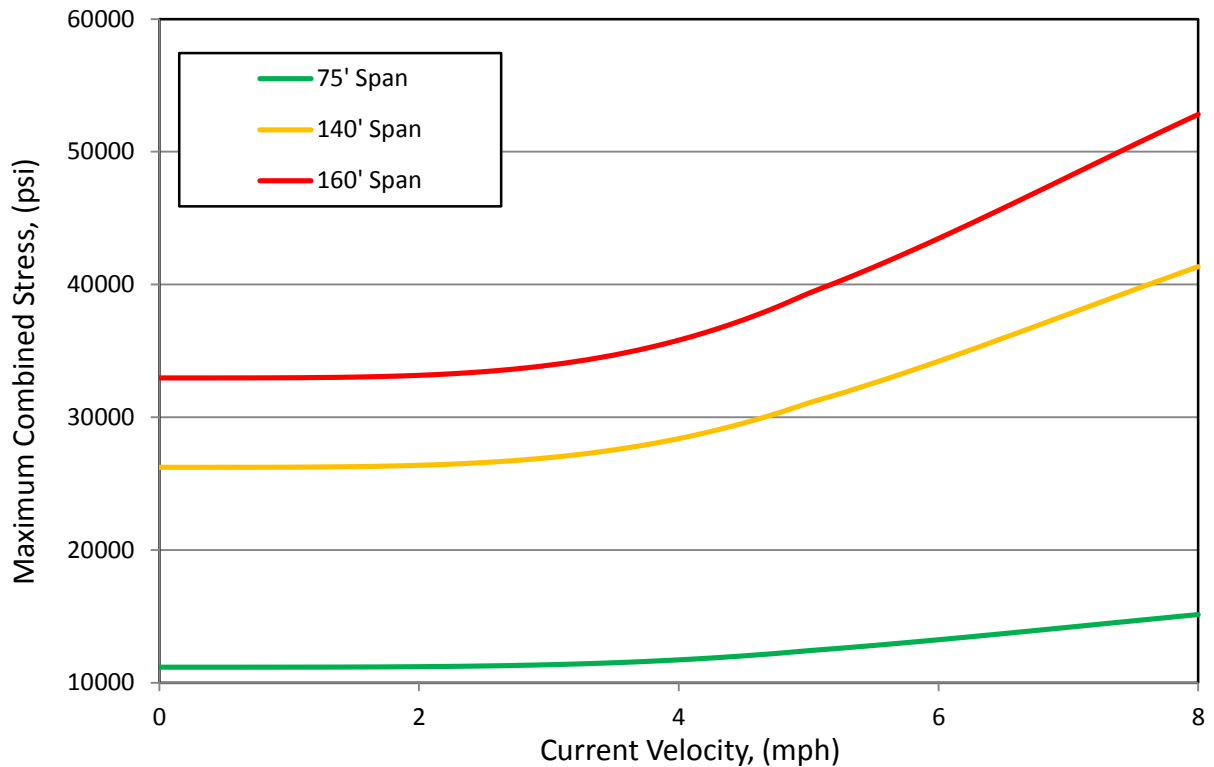
Figure 31. Maximum Combined Stress for Line 5 as a Function of Current Velocity

Figure 31 shows the maximum combined stress from pressure, gravitational and drag forces as a function of current velocity. Up to about the design specification current velocity (2.25 mph), the current has little effect on combined stress. X35 steel has a specification yield stress of 35,000 lb/in². At the easement specified minimum unsupported span of 75', the structure has a safety margin of ~three compared to the yield strength of the steel. At Salvadori's recommended maximum unsupported span of 140 the design is at 75% of the yield strength which is greater than the ASME B31.4 code requirement of 72% maximum. At the 160' unsupported span that is found on the 1964 as built blueprints and not fully corrected until 2001, the design is at 97% of yield. Referring to Figure 30, a current of 3.6 mph will push the

design to yield at 35000 lb/in² stress. These calculations show the rationale for the 75' easement limit and the wisdom of Salvadori's 140' absolute maximum span limitation.

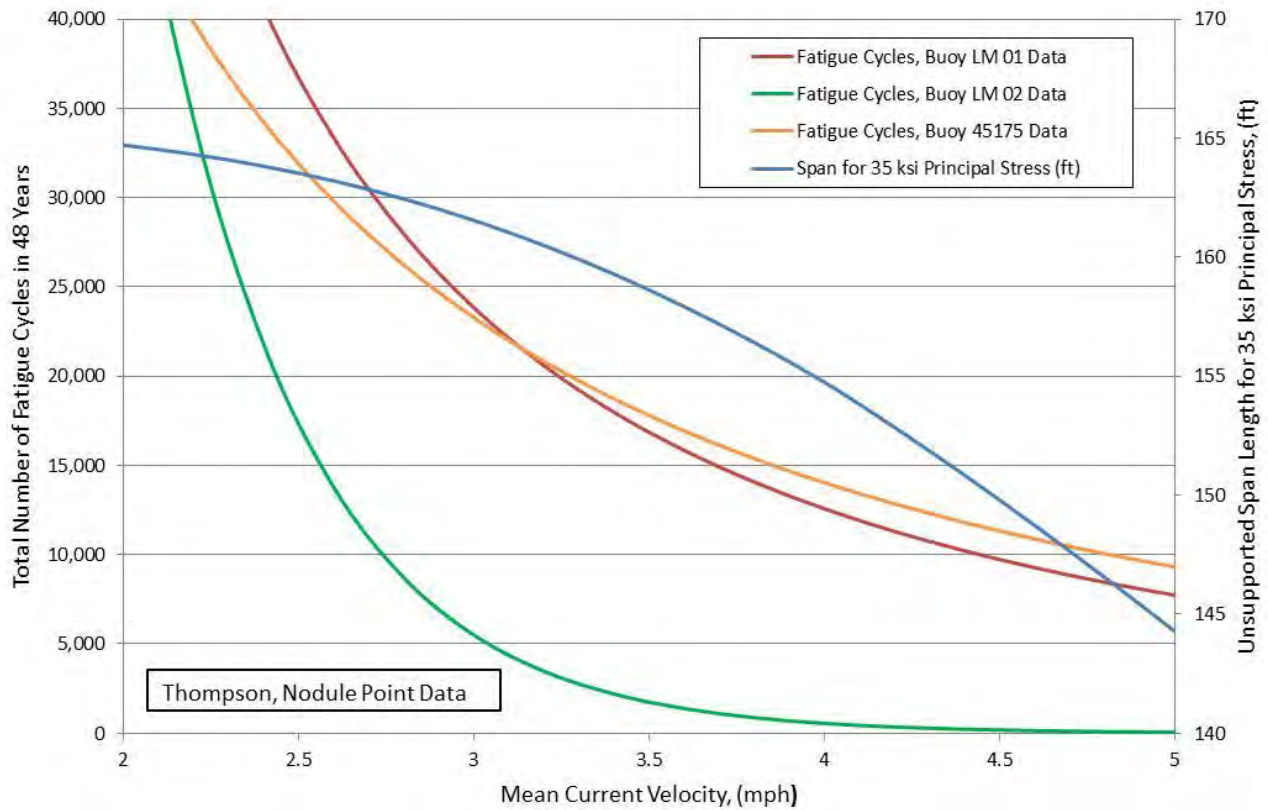
Figure 33. Total Number of Yield Cycles and Unsupported Span Length as a Function of Current Velocity for a Turbulence Wavelength of 164' (50 m)

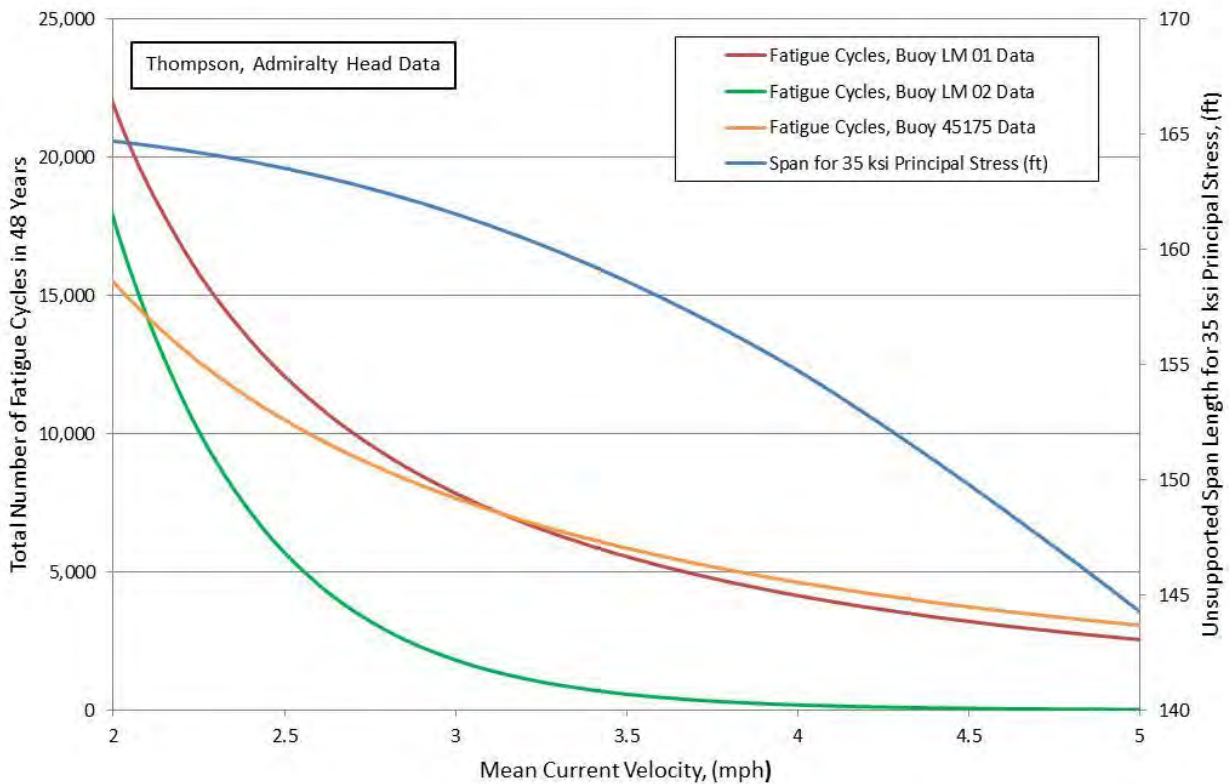
Figure 34. Total Number of Yield Cycles and Unsupported Span Length as a Function of Current Velocity for a Turbulence Wavelength of 492' (150 m)

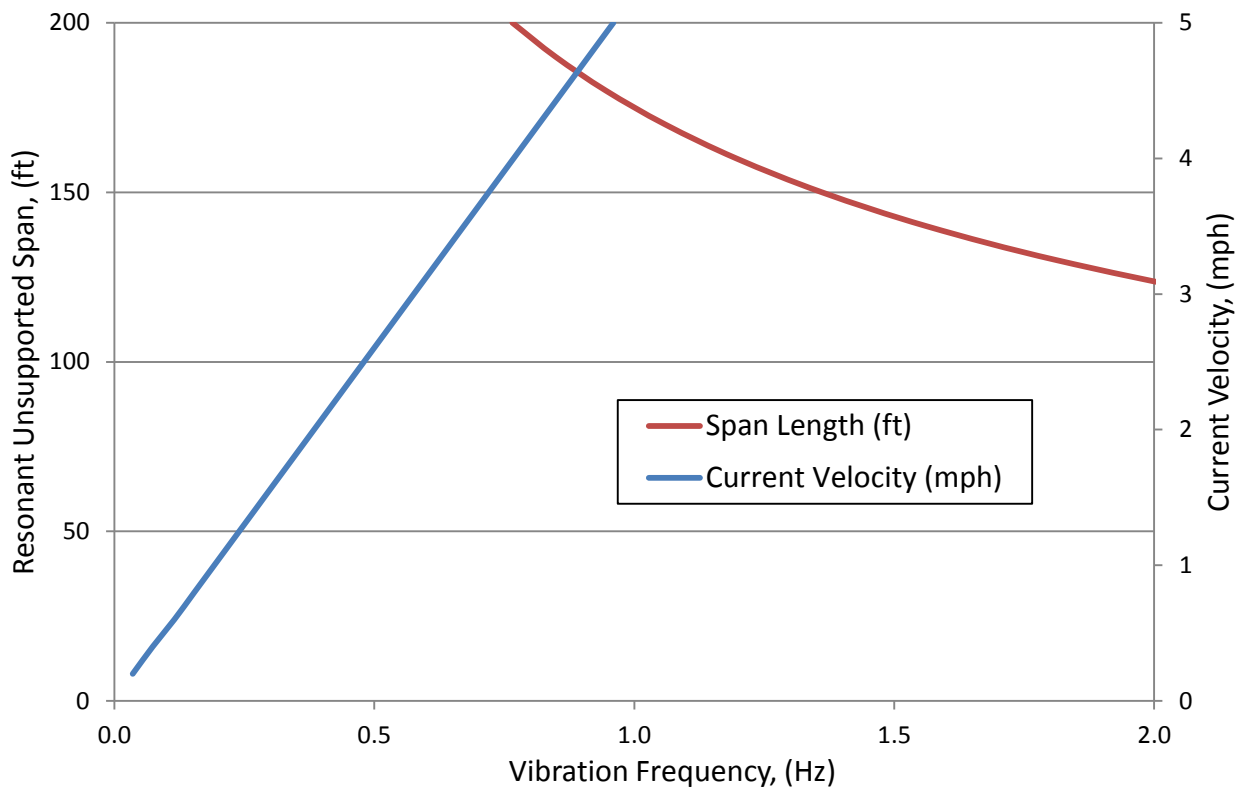
Figure 35. Resonant Unsupported Span Length and Current Velocity for Vortex Shedding as a Function of Frequency

Vortex shedding frequencies for Line 5 in the same condition as used for the previous drag calculations were computed using the data in Figure 27. The first fundamental transverse vibration frequency for the pipe was calculated according to Blevins²⁶. Figure 33 is a plot of the results of these computations. It can be seen from this figure that at a current velocity of 4.6 mph and an unsupported span length of 185', vortex shedding lock-in will occur at a frequency of 0.88 Hz.

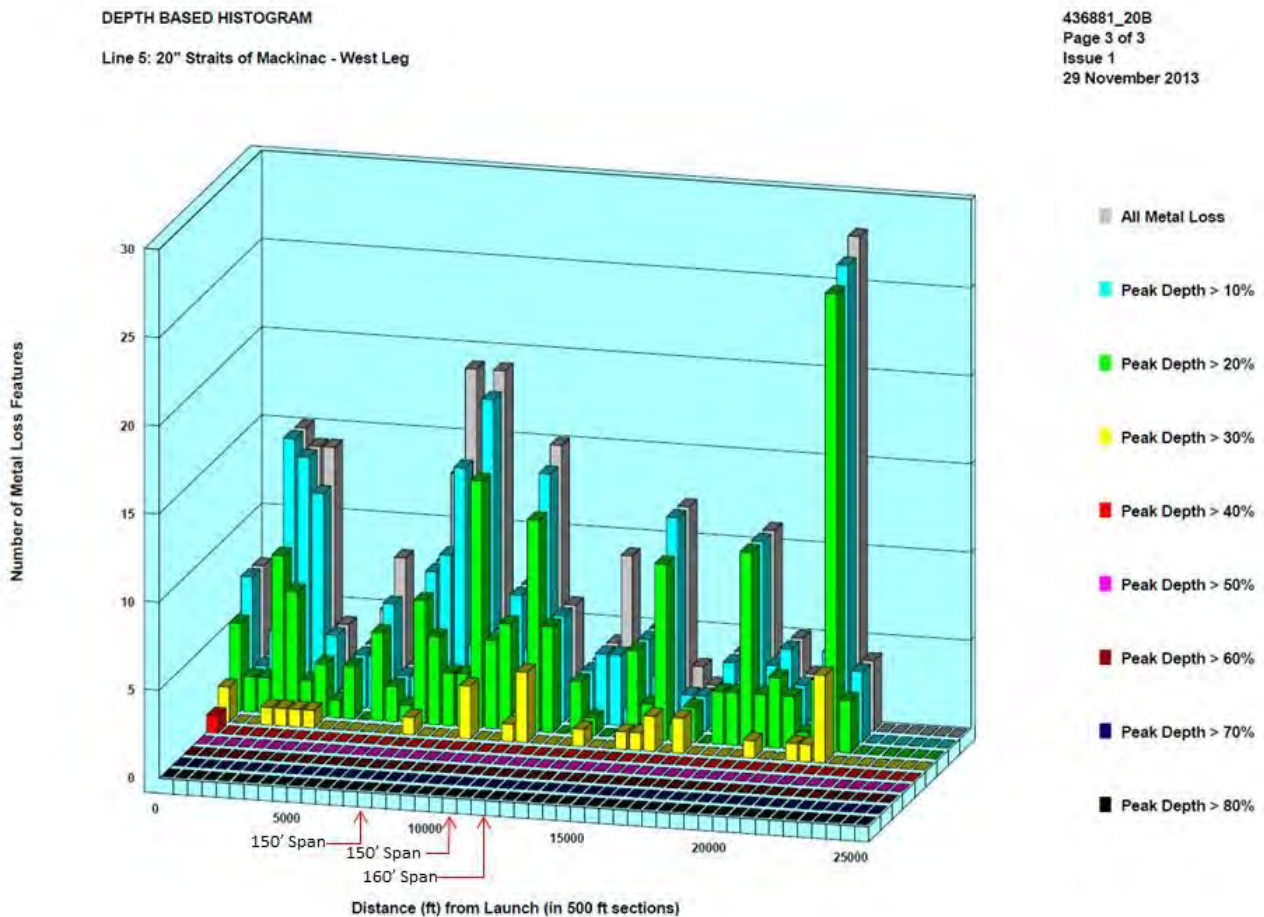
Figure 38. Annotated Histogram of Metal Loss Features in the West Leg of Line 5 from a 2013 MFL Inspection Report²⁸.

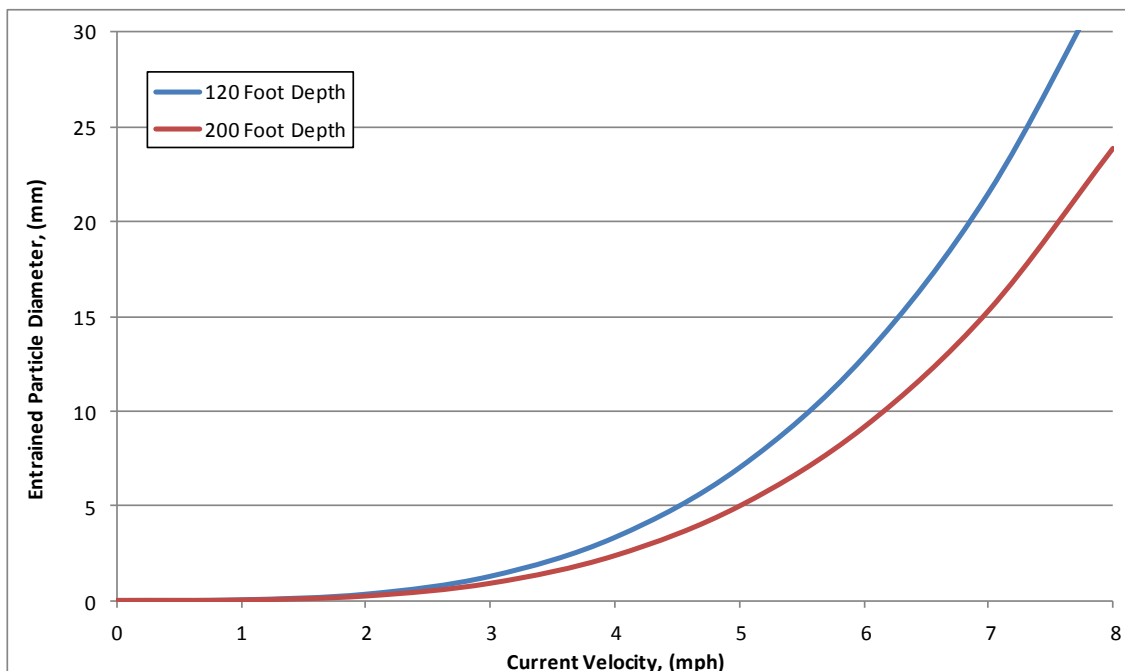
Figure 1. Soil Particle Entrainment Velocity as a Function of Underwater Current Velocity

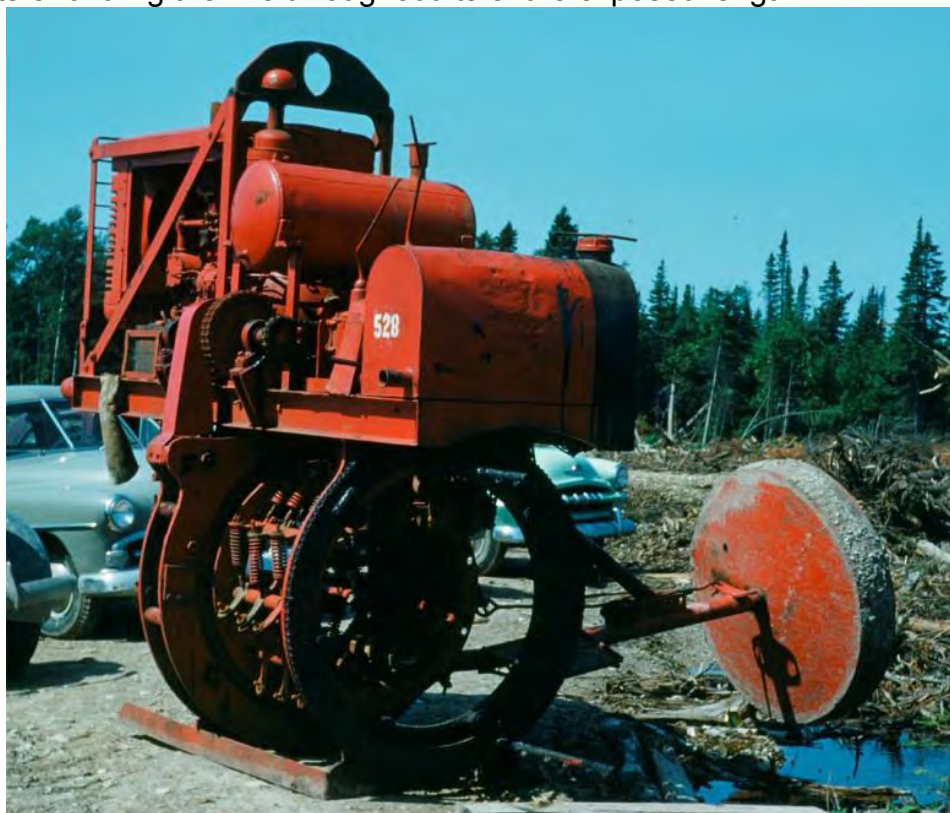
Figure 1. Trudgen Photo of Pipe Cleaning Machine (00010370013.tif)

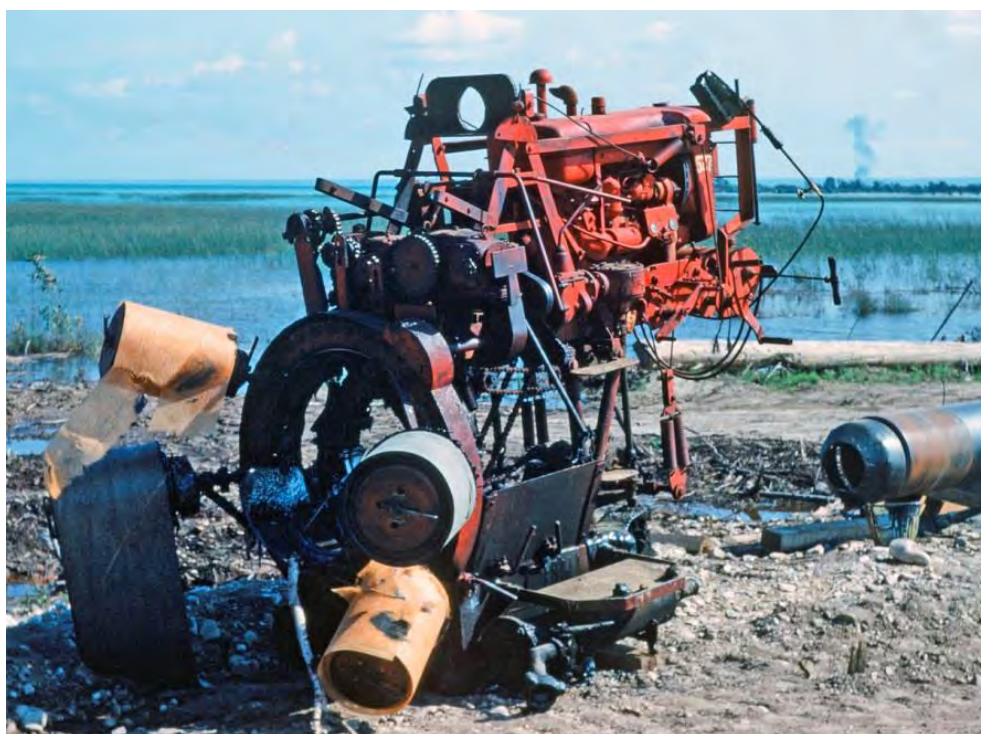
Figure 2. Trudgen Photo of Pipe Wrapping Machine (00010370012.tif)

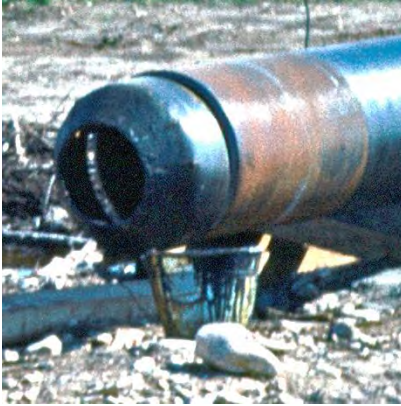
Figure 3. Detail Enlarged from Trudgen Photo of Pipe Wrapping Machine Showing Wrapped Pipe (00010370012.tif)

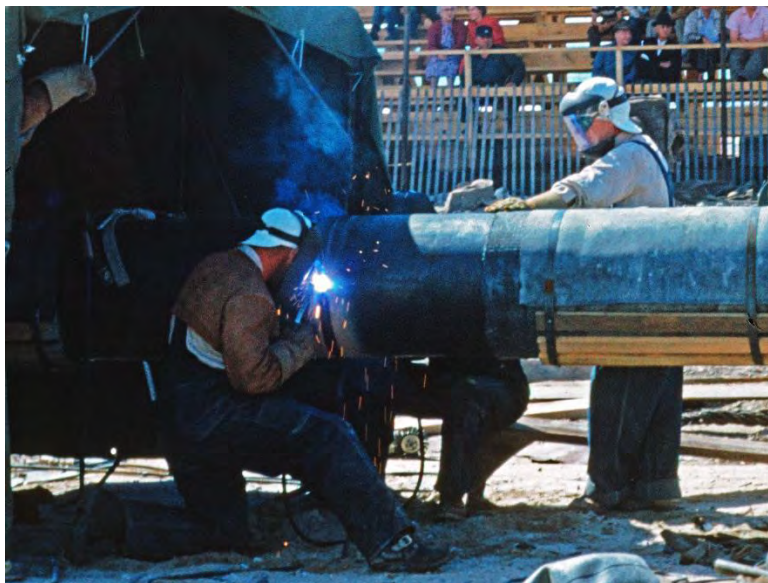
Figure 5. Trudgen Photo of Pipe String Assembly Welding (00010370005.tif)

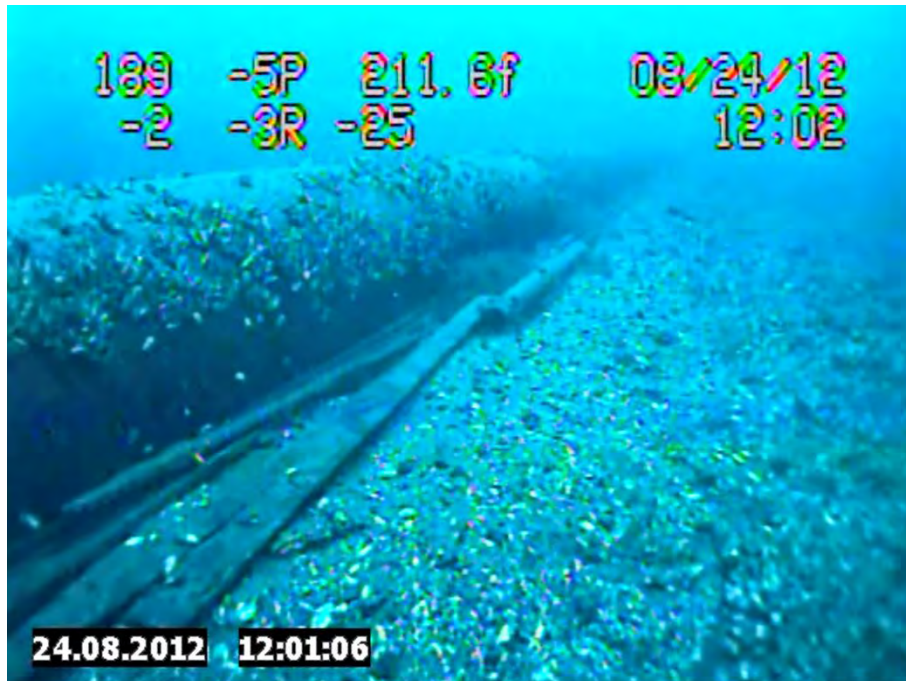
Figure 6. Photo Clipped from Enbridge 2012 Underwater Inspection Video of the West Line Taken on 8/24/2012 at 12:01:06 Showing Detached Slats.

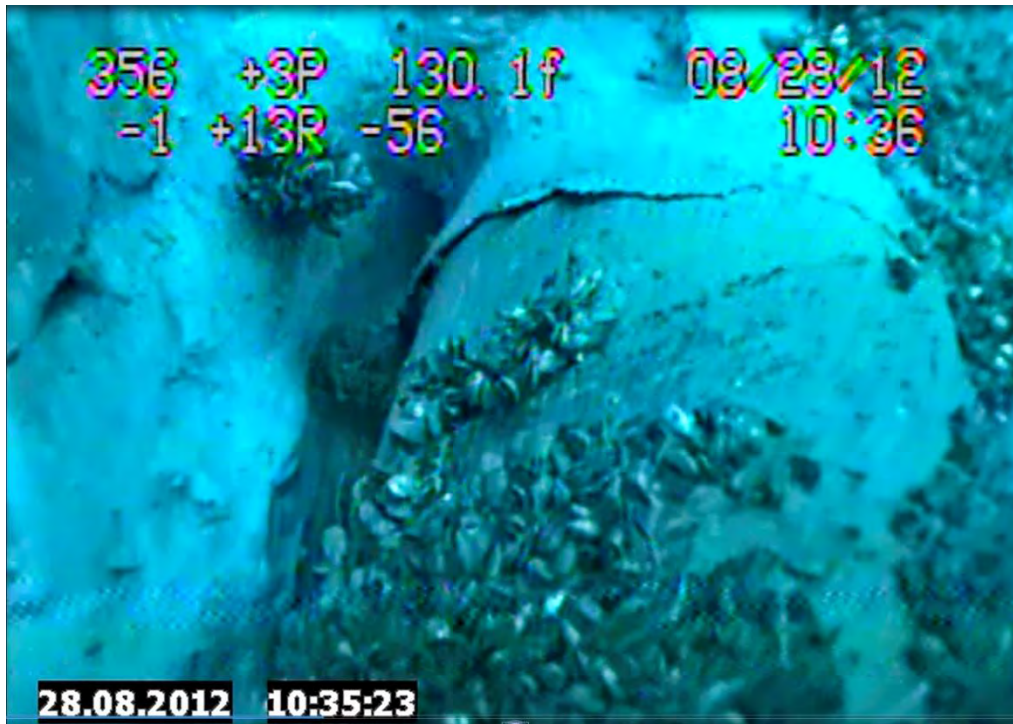
Figure 7. Photo Clipped from Enbridge 2012 Underwater Inspection Video of the East Line Taken on 8/28/2012 at 10:35:23 Showing Missing and Disbonded Coating

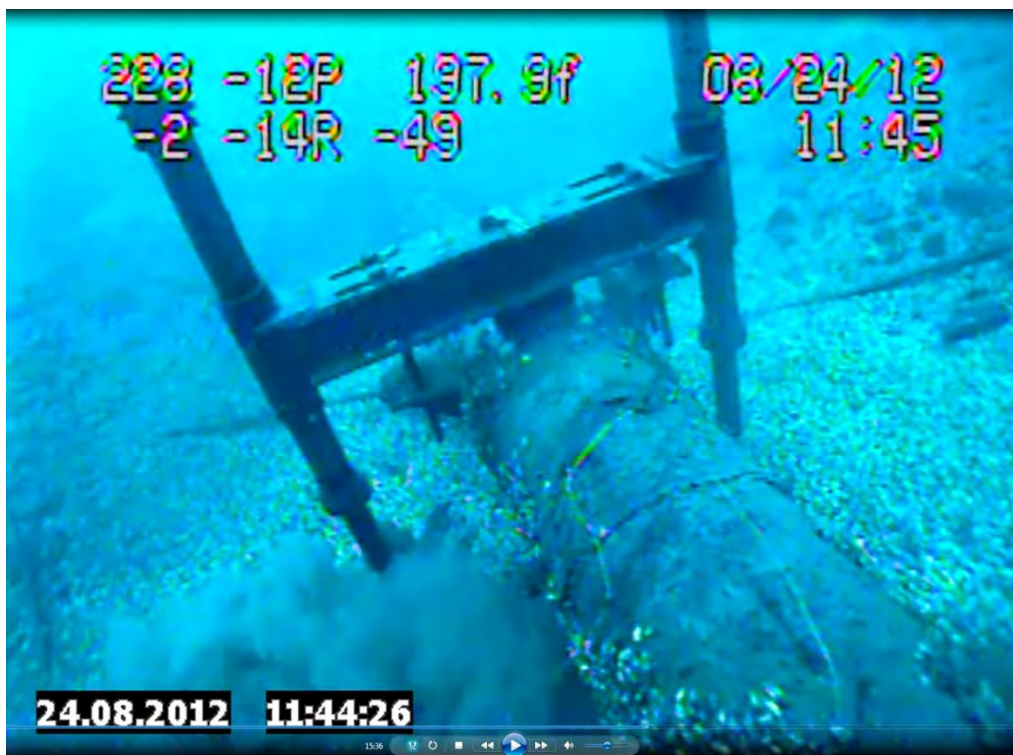
Figure 8. Photo Clipped from Enbridge 2012 Underwater Inspection Video of the East Line Taken on 8/24/2012 at 11:44:26 Showing Missing and Disbonded Coating

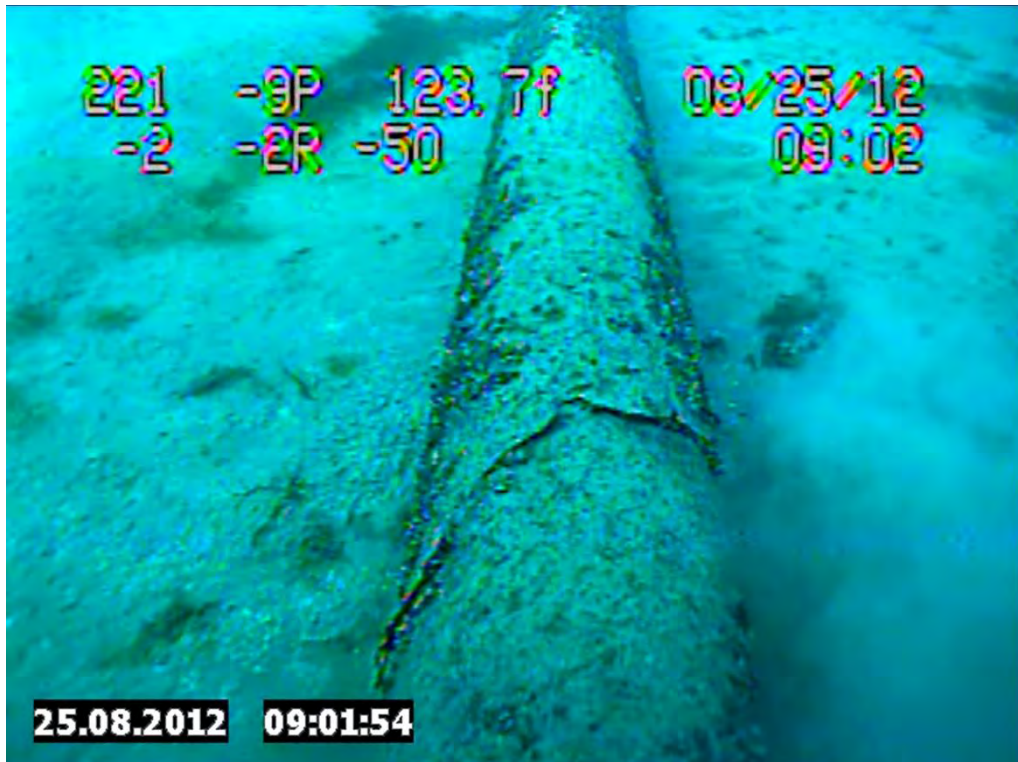
Figure 9. Photo Clipped from Enbridge 2012 Underwater Inspection Video of the East Line Taken on 8/25/2012 at 09:01:54 Showing Missing and Disbonded Coating

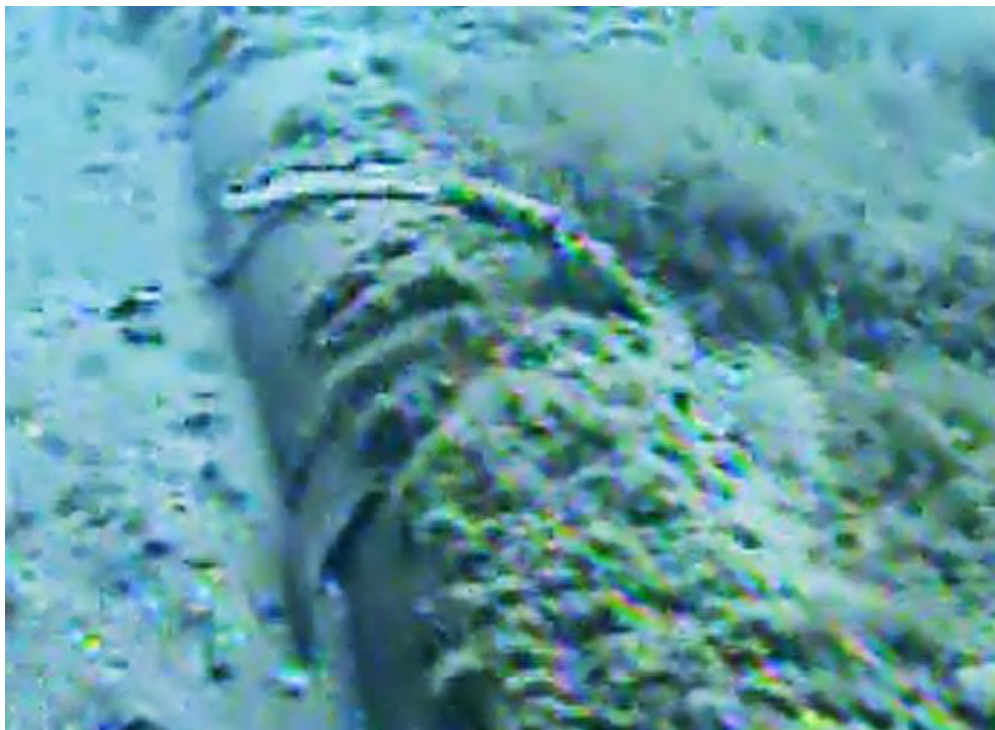
Figure 10. Detail from Photo Clipped from Enbridge 2012 Underwater Inspection Video of the West Line Taken on 8/25/2012 at 15:58:44 Showing Disbonded Coating and Broken Band

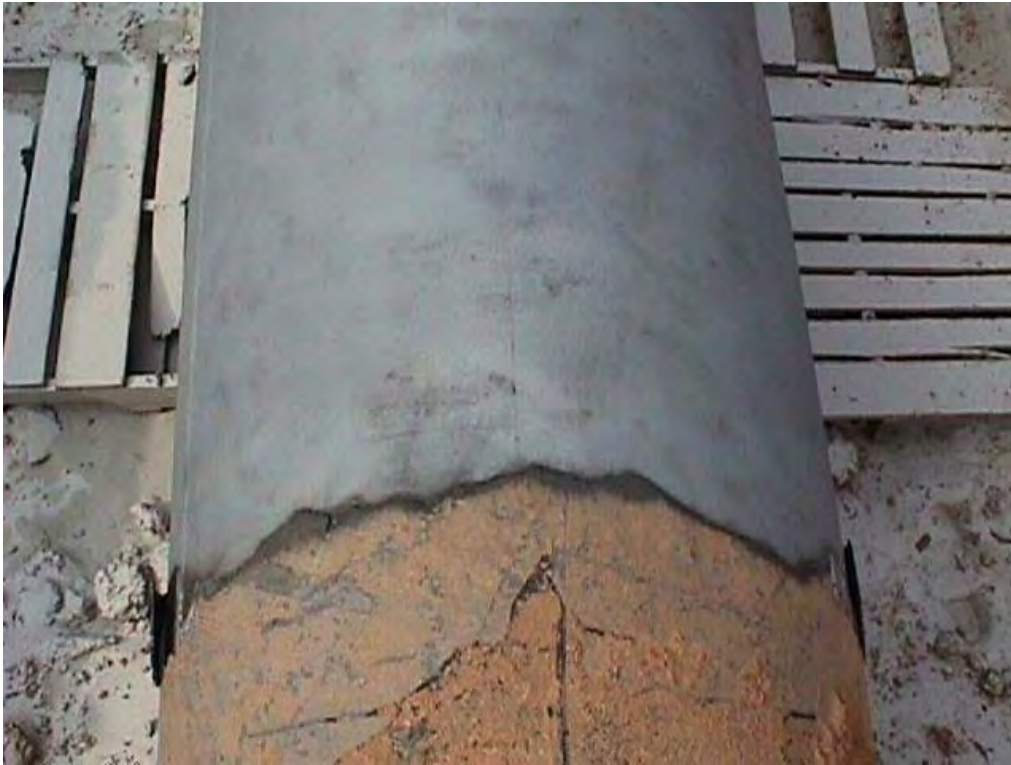
Figure 12. Typical Corrosion Found Under a Disbonded Coating as Reveled by Light Abrasive Blasting
